UNIVERSITY OF CALIFORNIA
BERKELEY

HISTORIC STRUCTURE REPORT

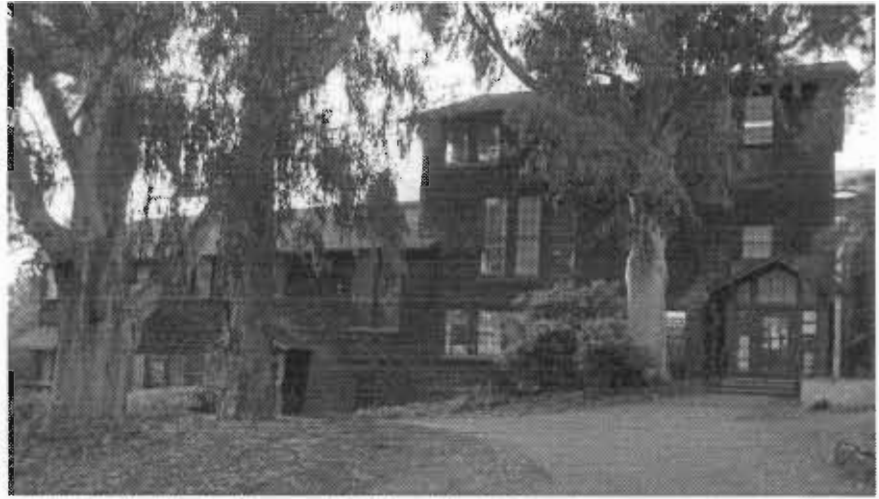
Figure 1. Naval Architecture Building: South Facade

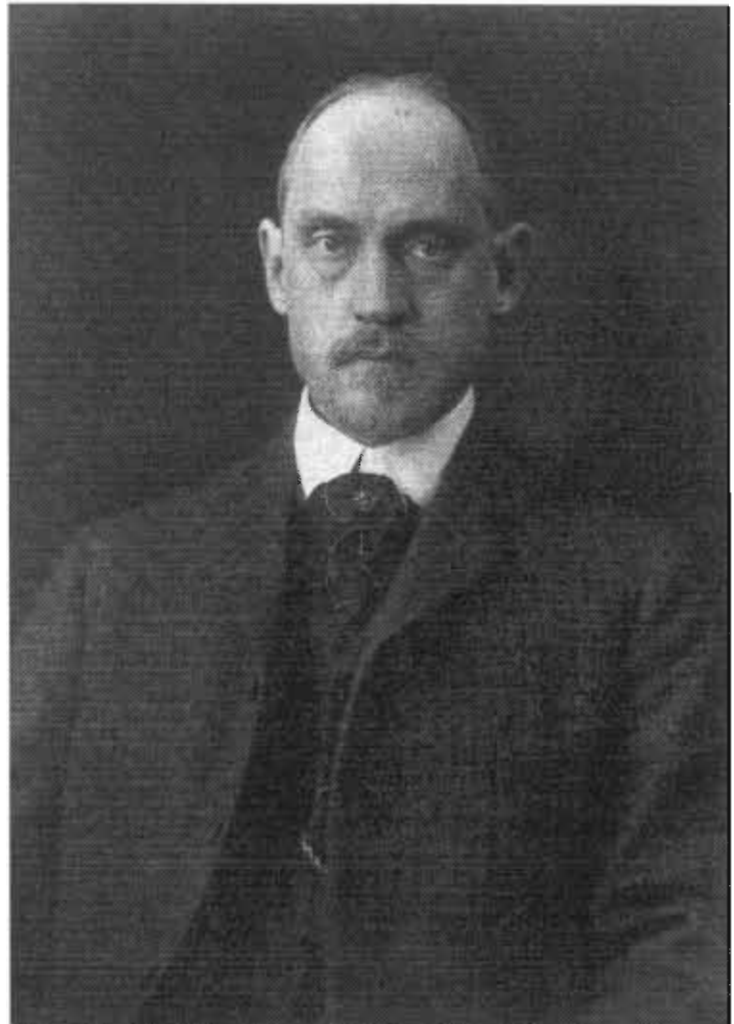
Figure 3. John Galen Howard (photo: Moss, *The Howards*)

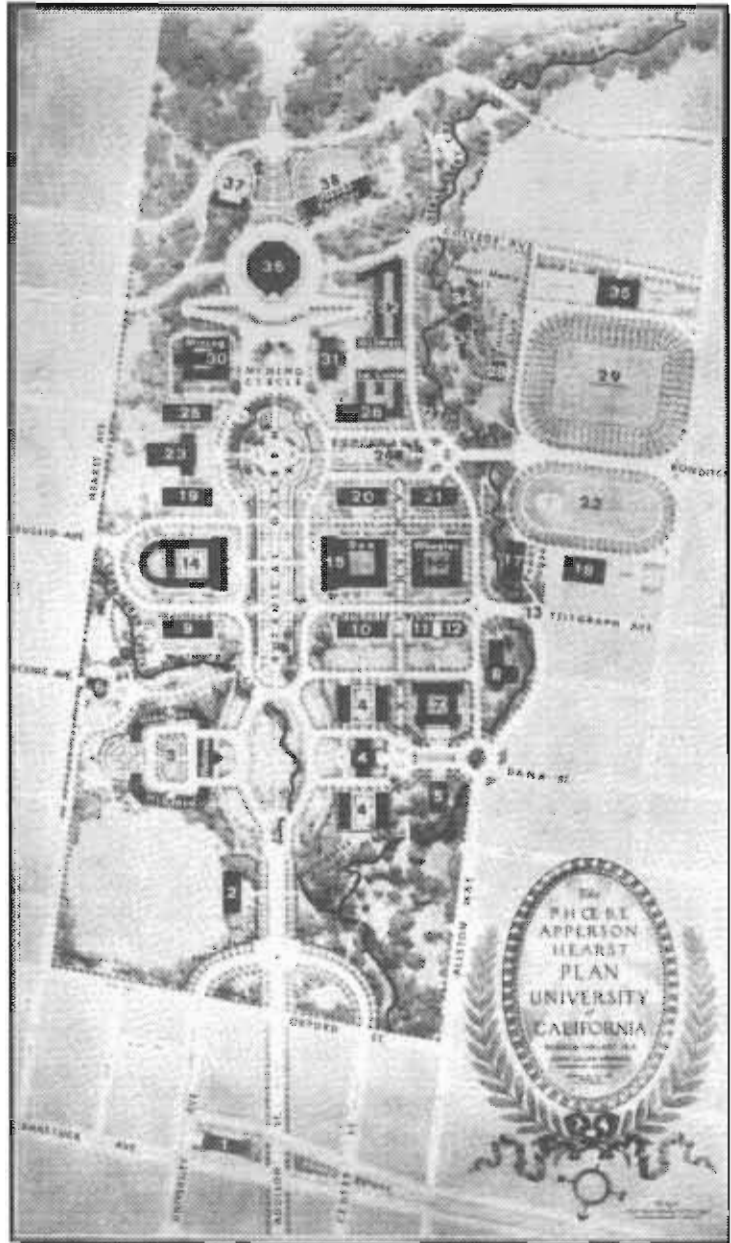
Figure 4. University of California Master Plan (JGH 1914)
(drawing: Bancroft Library, UC Berkeley)

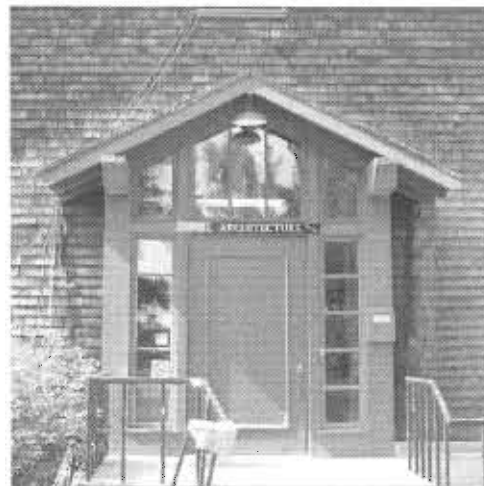
Figure 6. Original entry to Drawing Building

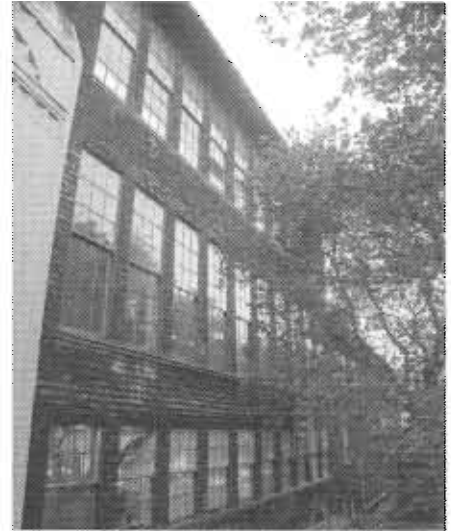
Figure 10. North facade of Addition

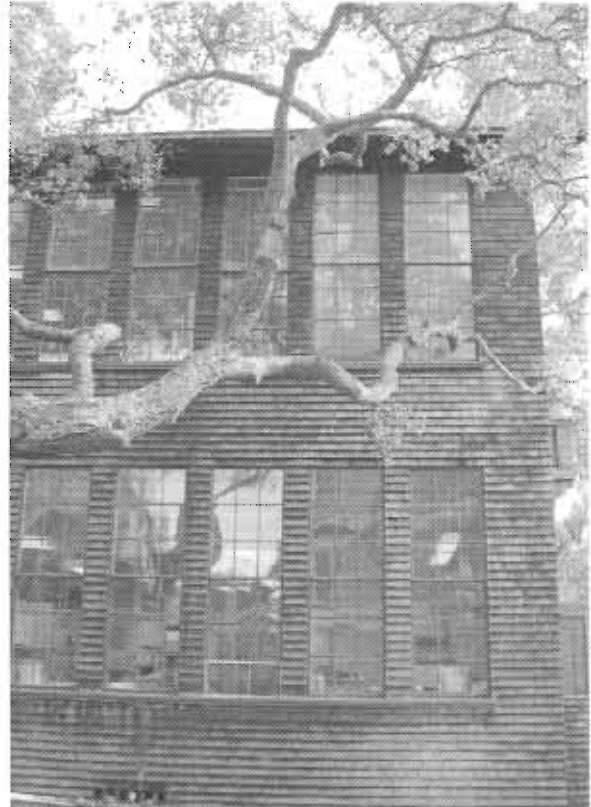
Figure 18. Studio Windows on North Façade

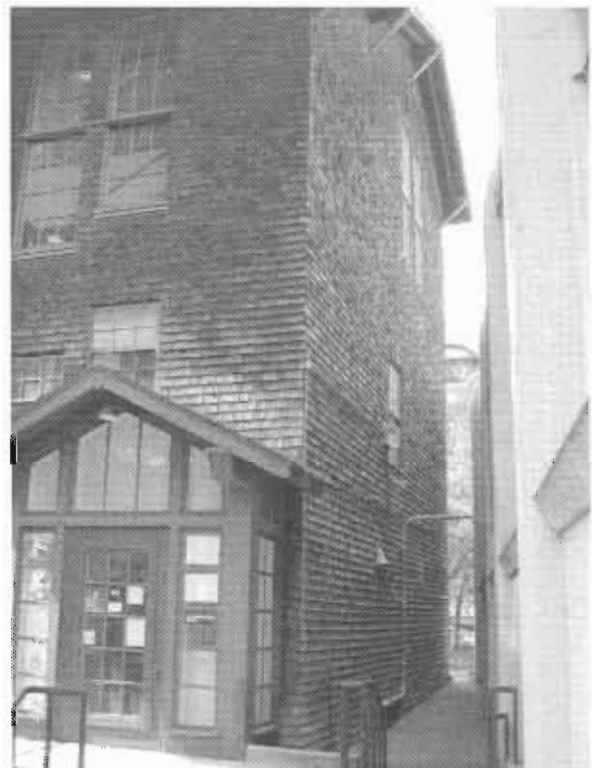
Figure 21. Entry to Addition

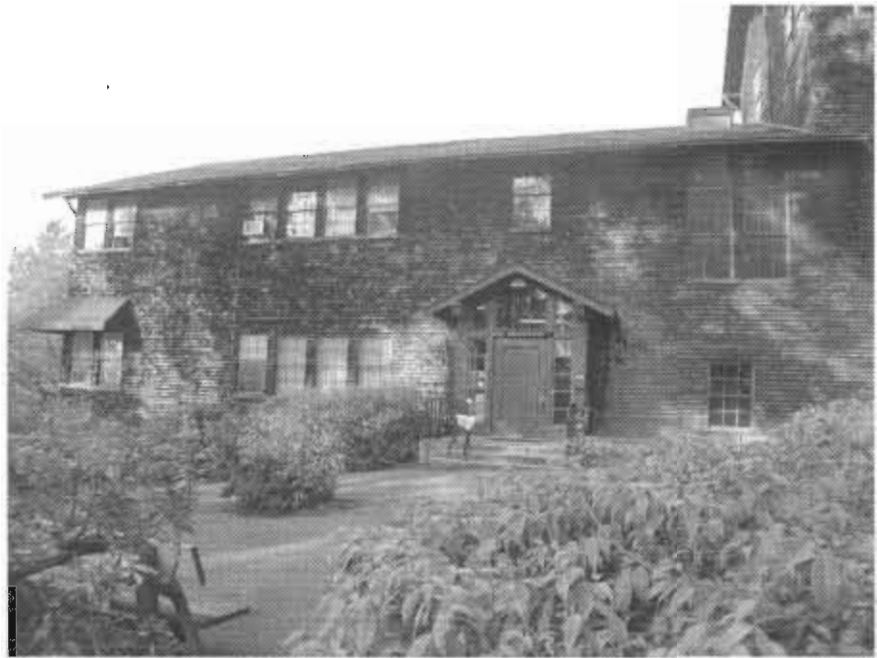
Figure 22. Drawing Building: South Facade

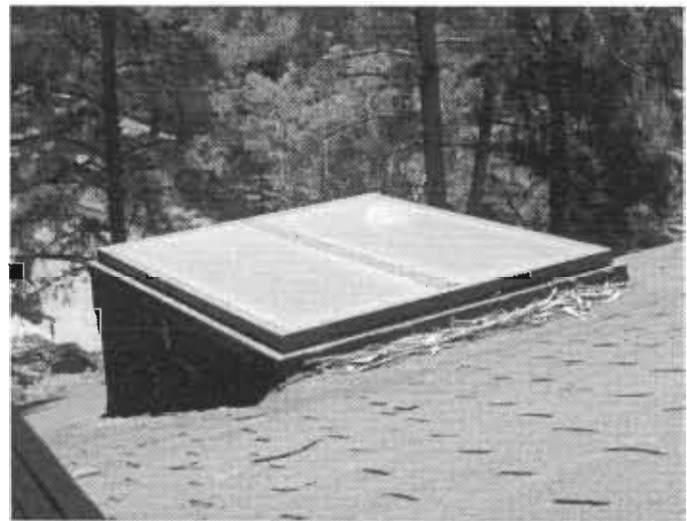
Figure 23. Skylight at Room #203

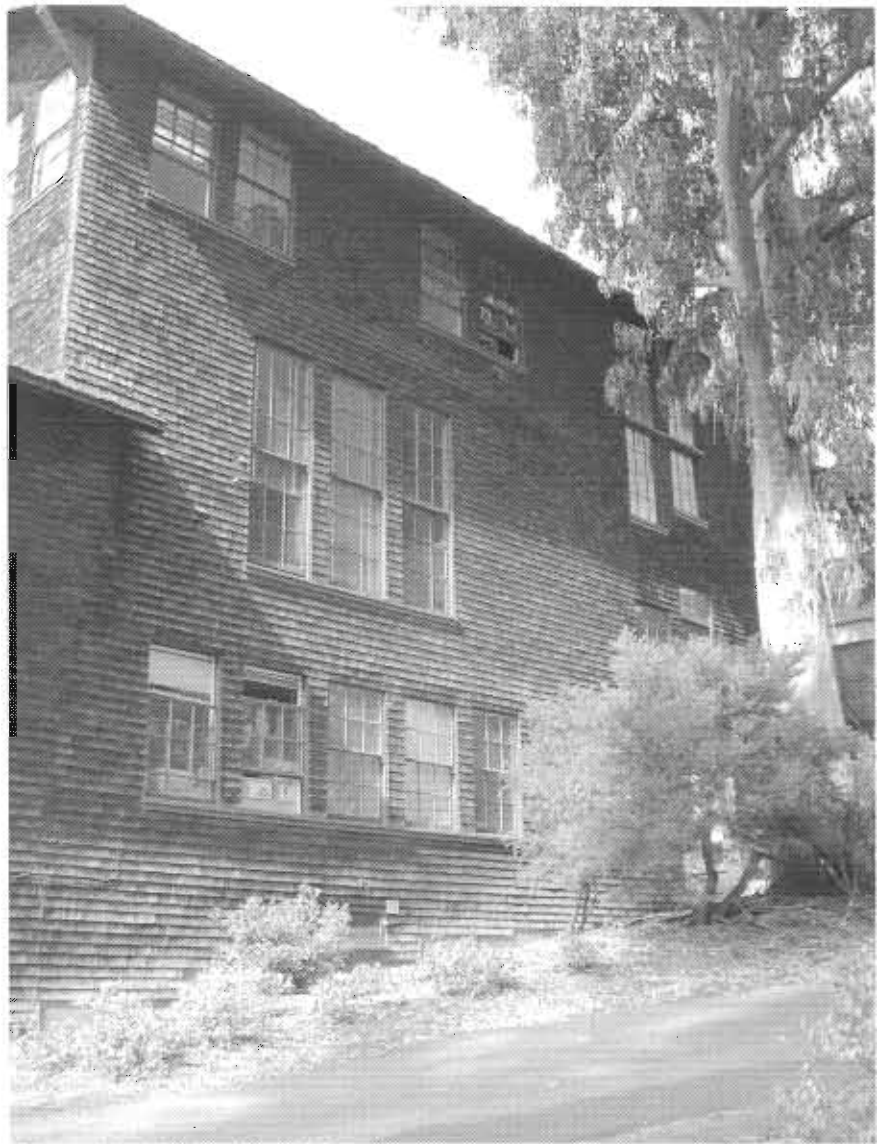
Figure 24. Addition: South Facade

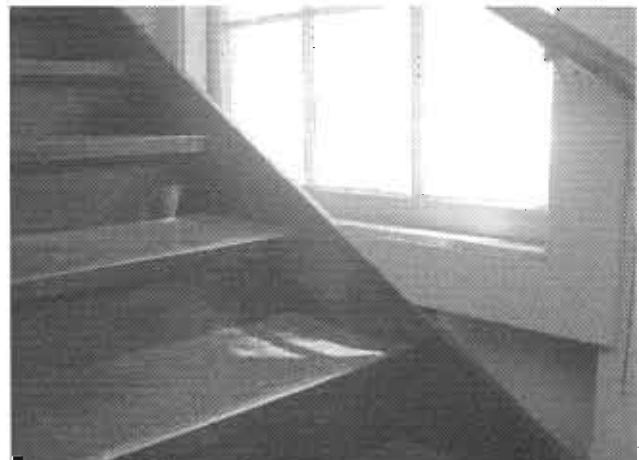
Figure 25. Relocated stair stringer crosses windows

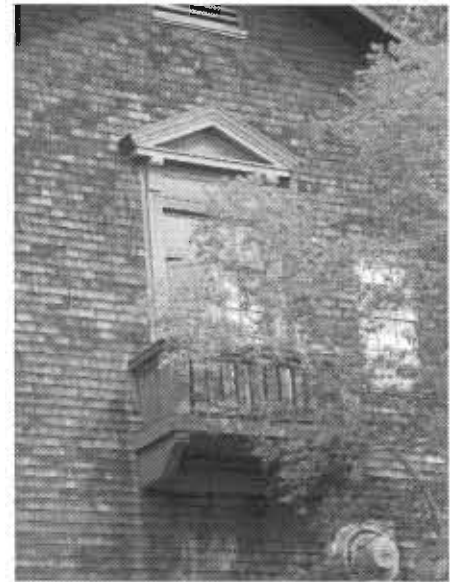
Figure 26. West Façade: Georgian inspired balcony

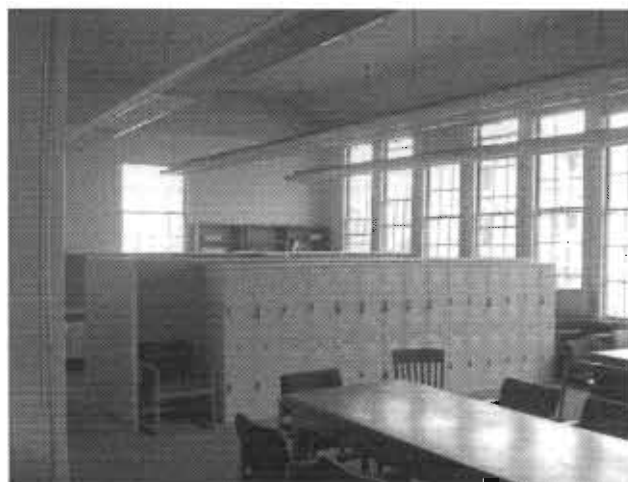
*Figure 33. Room #300*

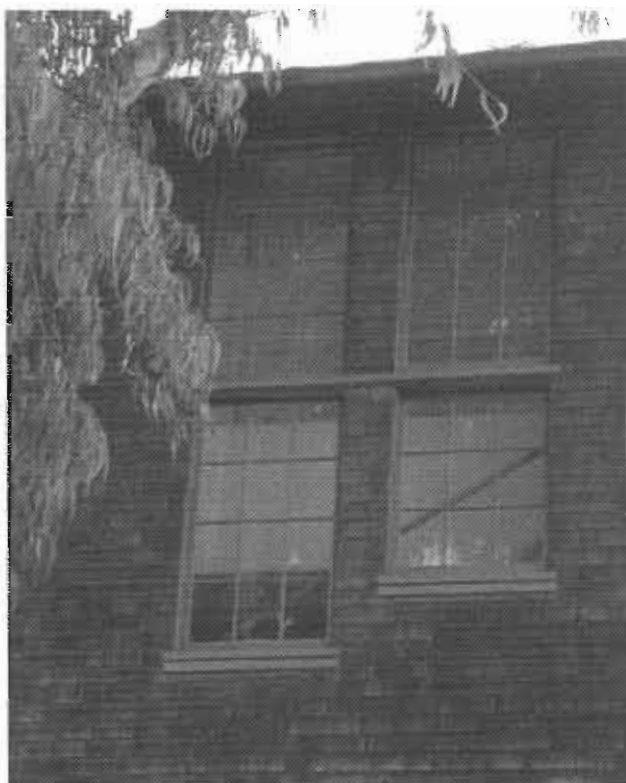
Figure 34. Windows at stairway on South Facade

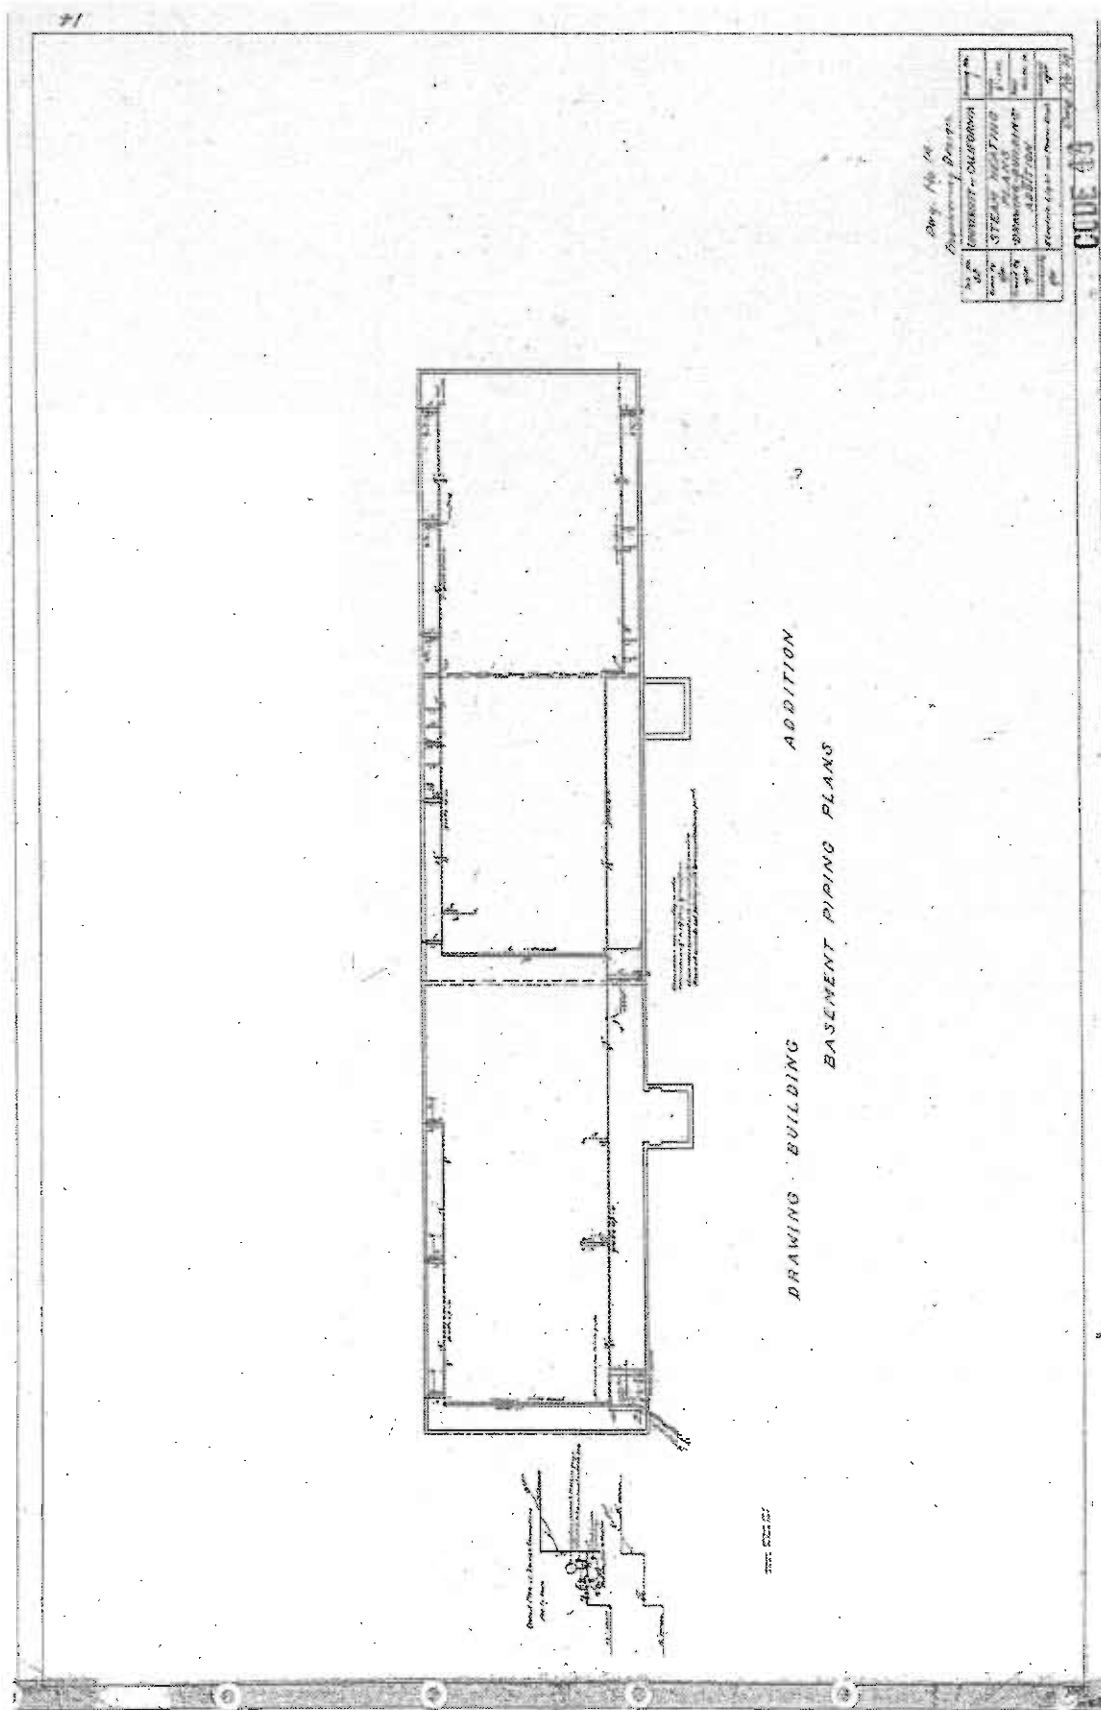
Figure 47. Drawing Building, Steam Heating Plan - Foundation Plan (Capital Projects, Plan Room, UC Berkeley)

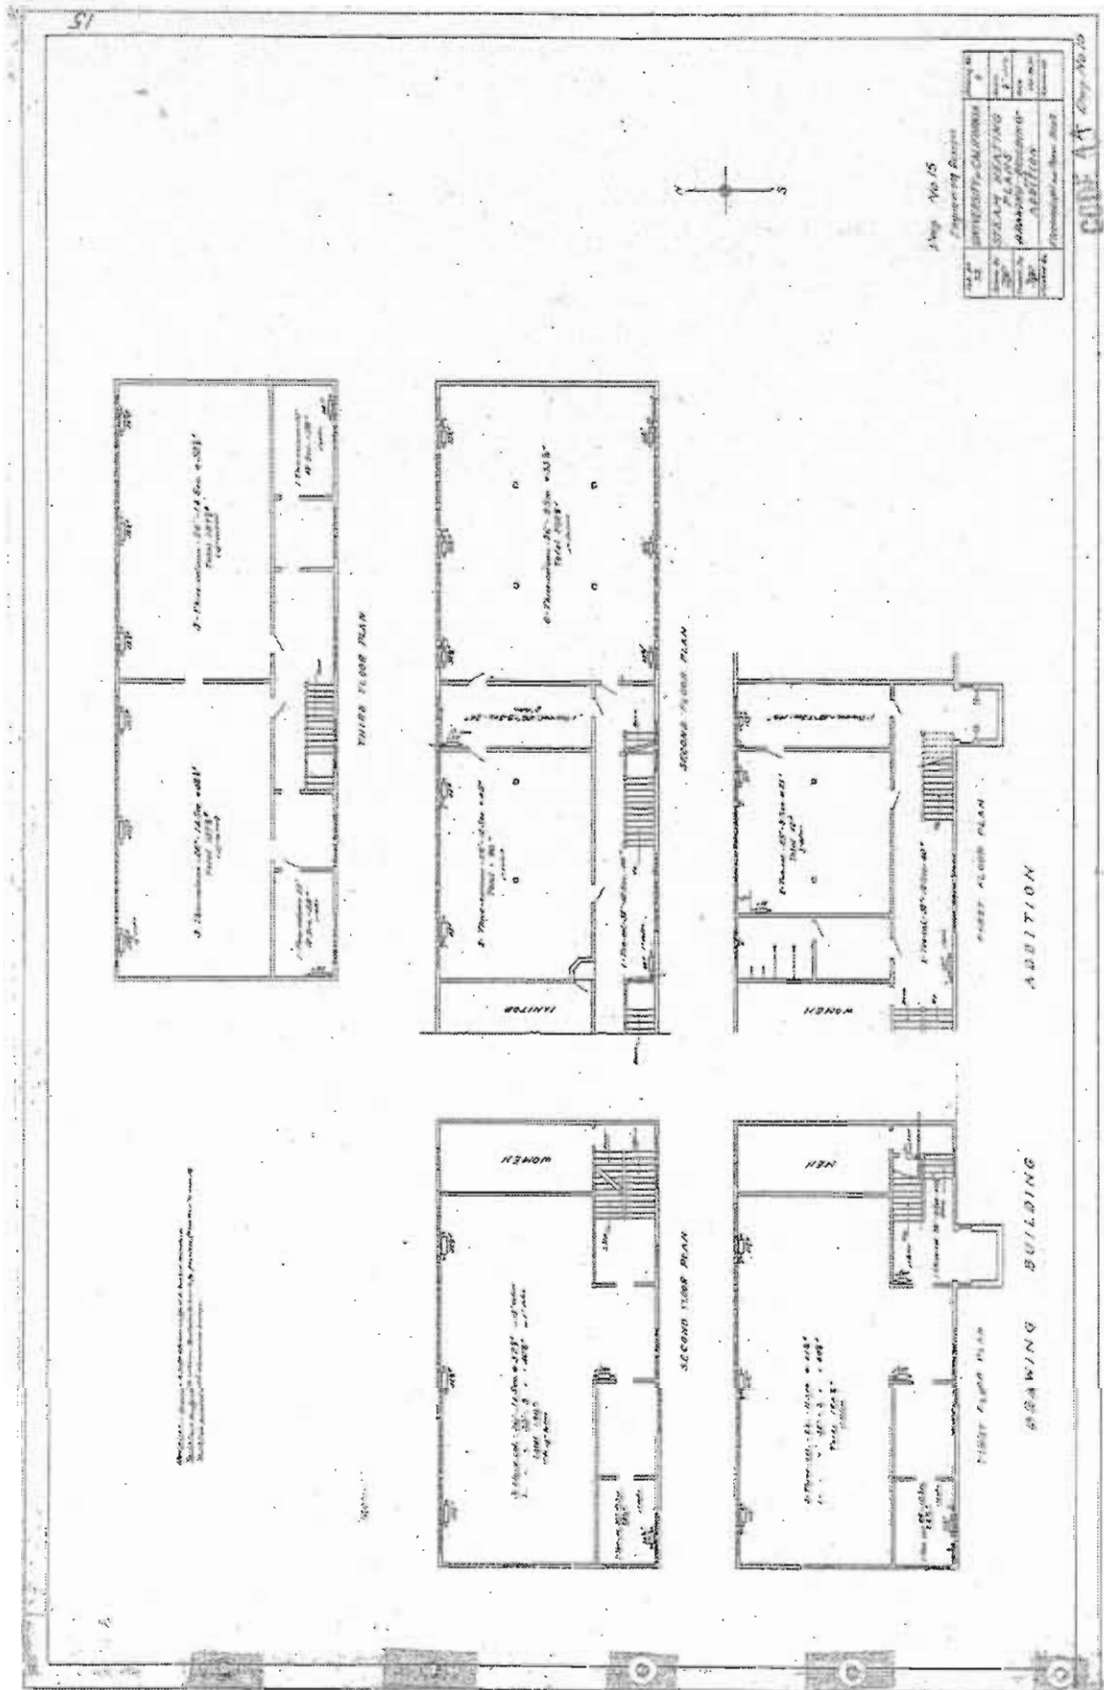
Figure 48. Drawing Building, Steam Heating Plan - Floor Plans (Capital Projects, Plan Room, UC Berkeley)

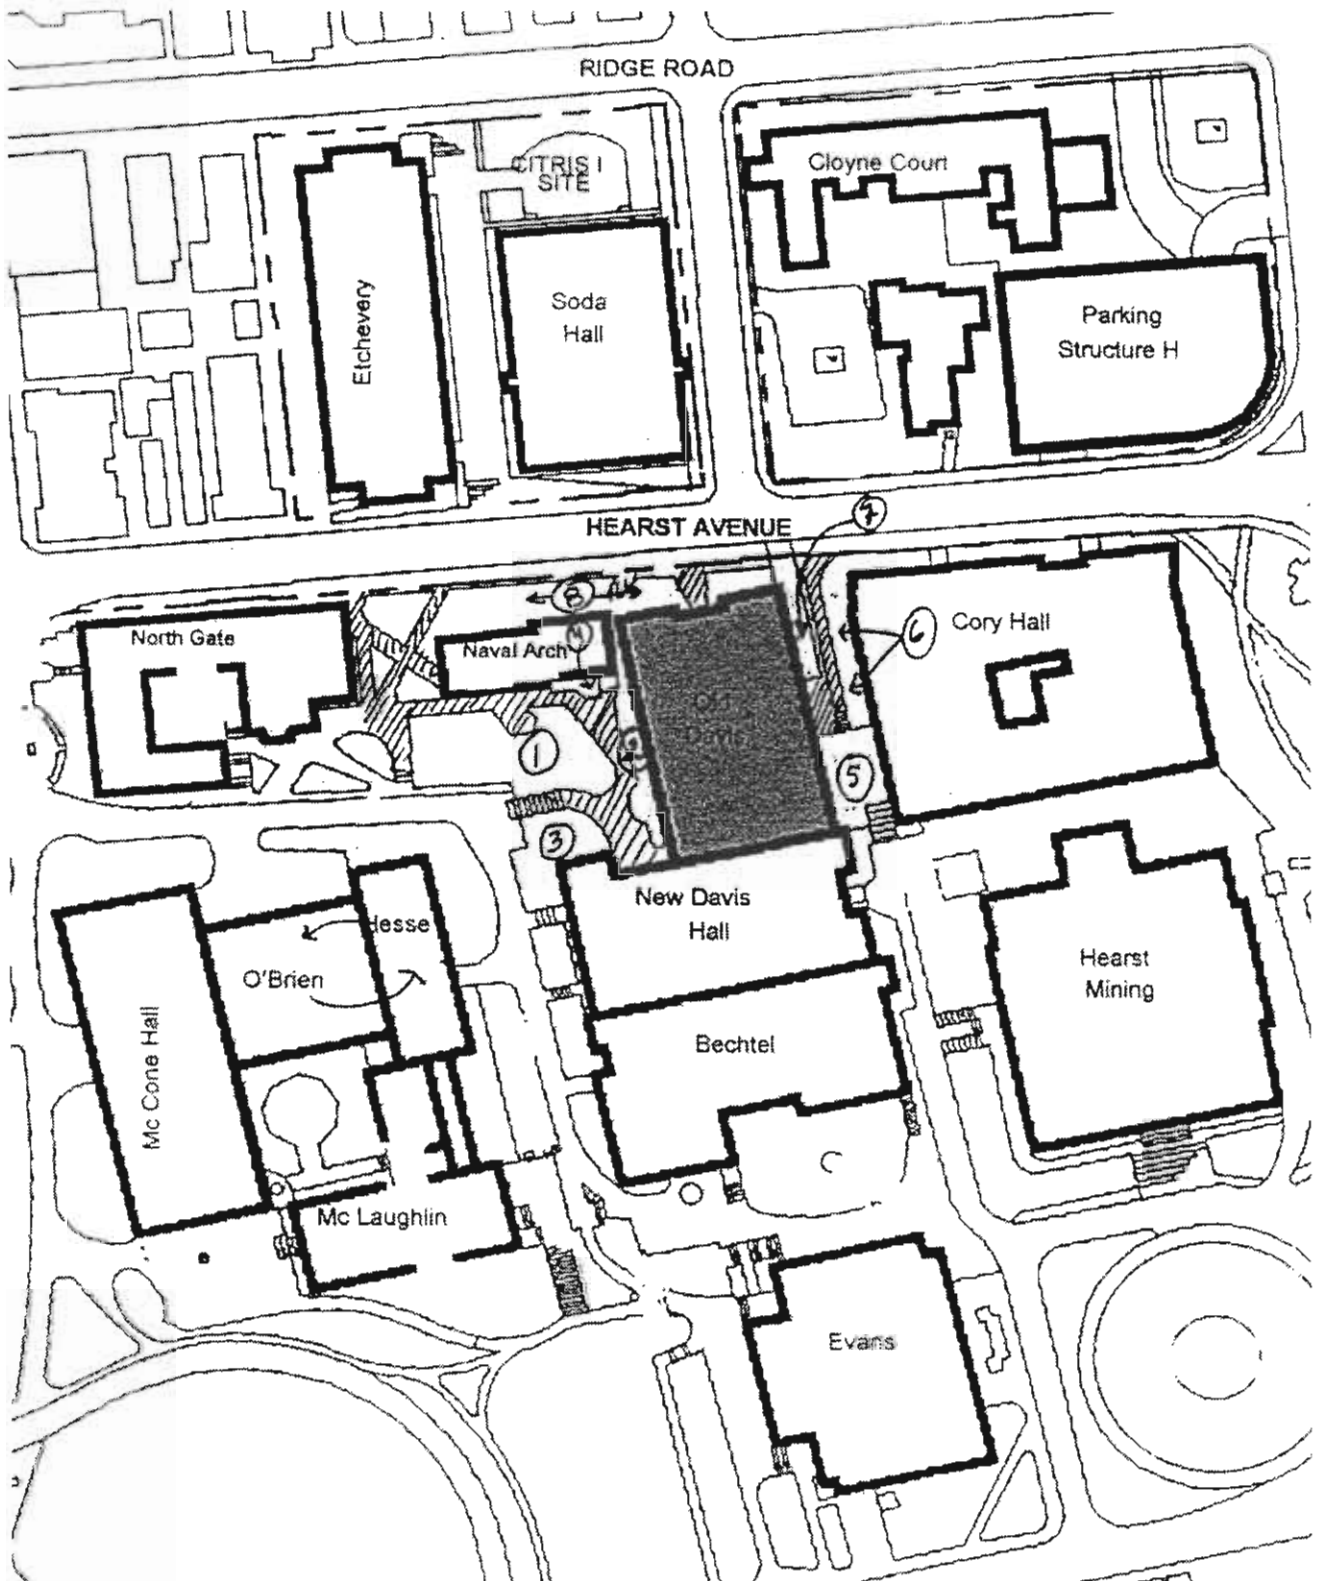
Figure 50. Plan: Description of Davis North Plants

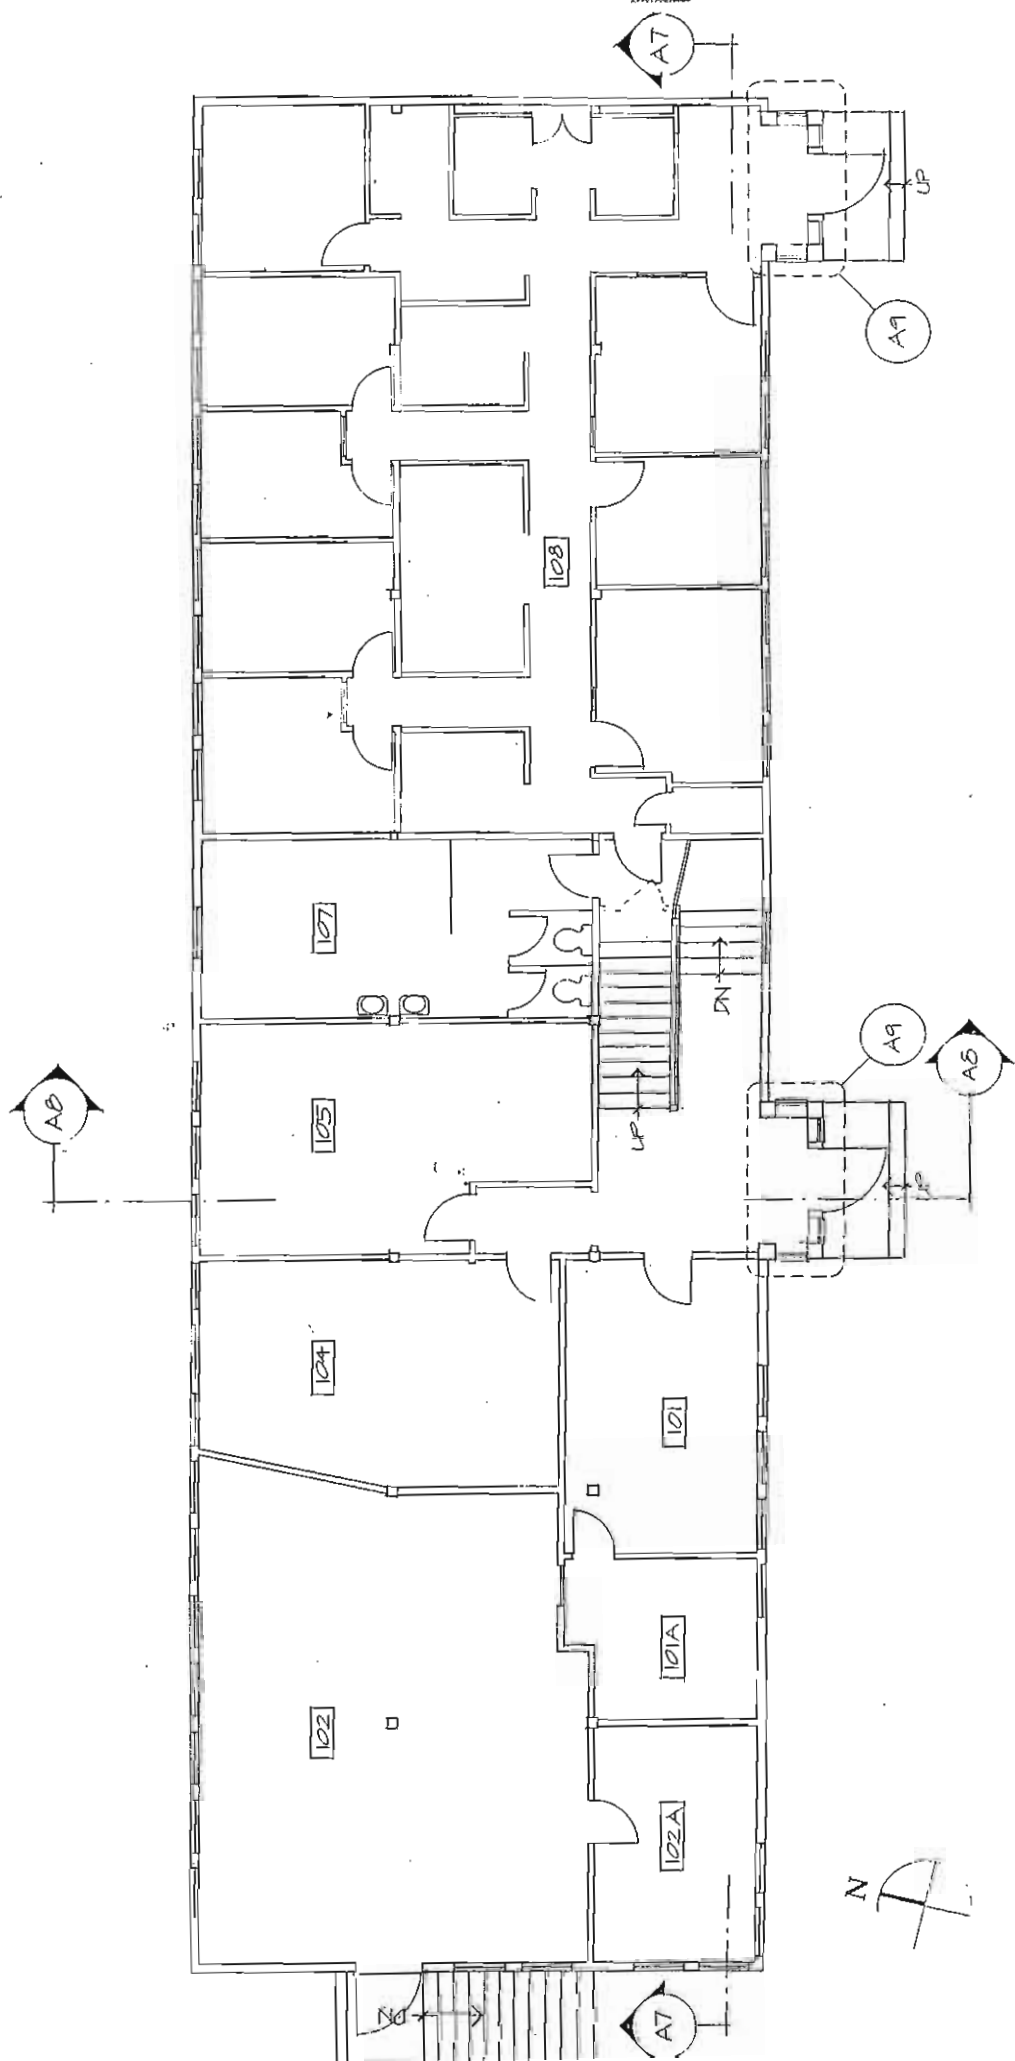
UNIVERSITY OF CALIFORNIA
 AT BERKELEY
 NAVAL ARCHITECTURE
 BUILDING STUDY

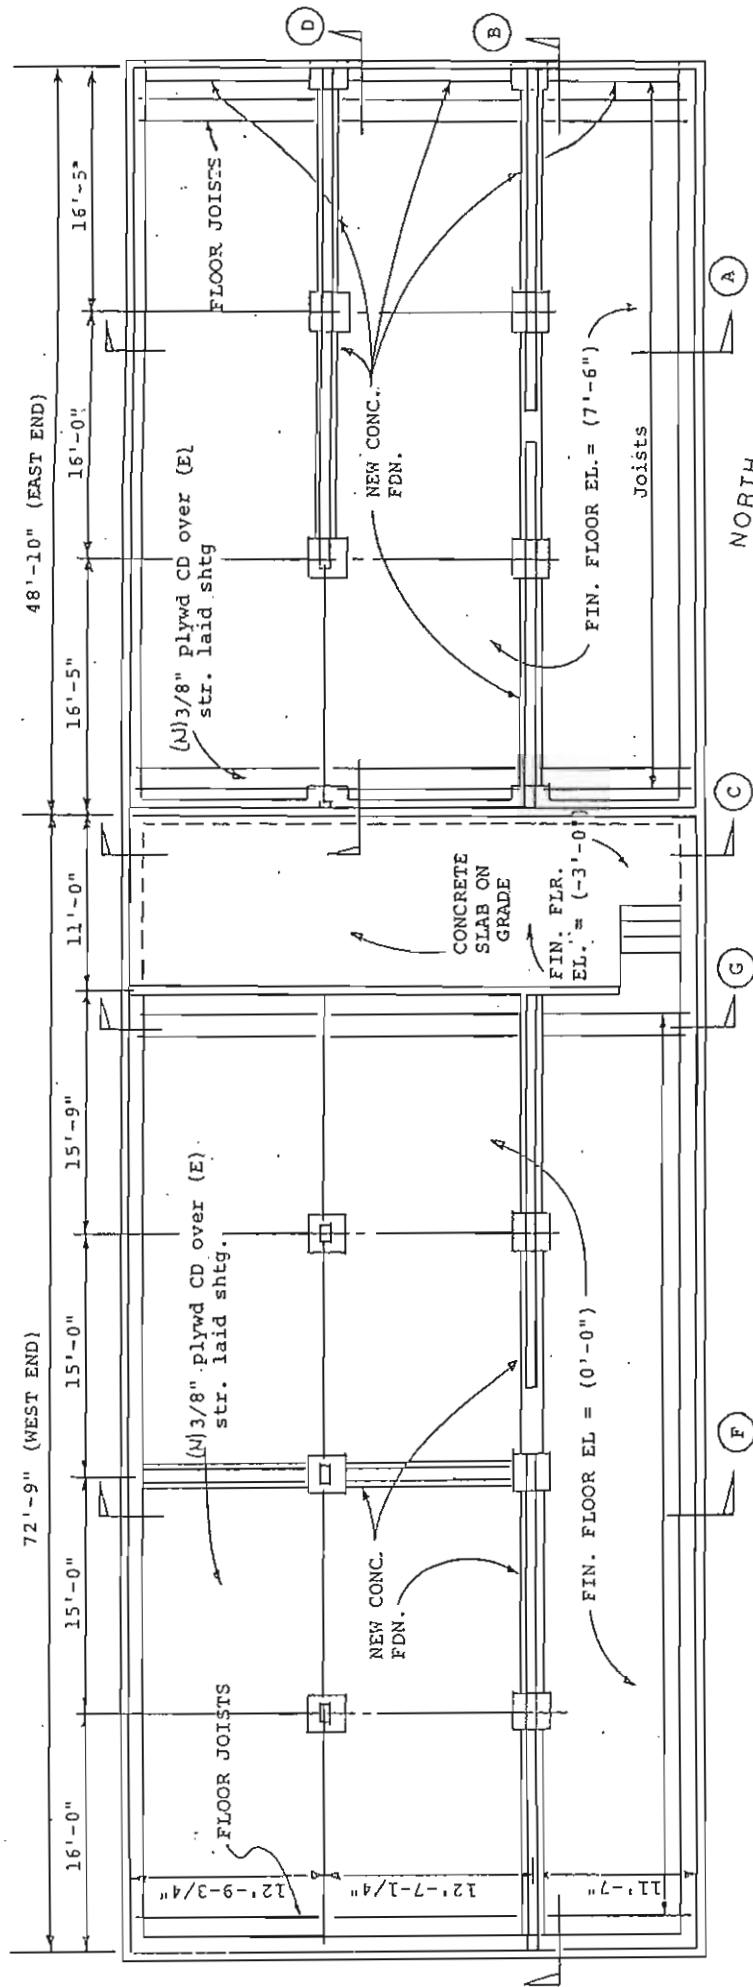
FOUNDATION AND FIRST FLOOR DIAPHRAGM PLAN

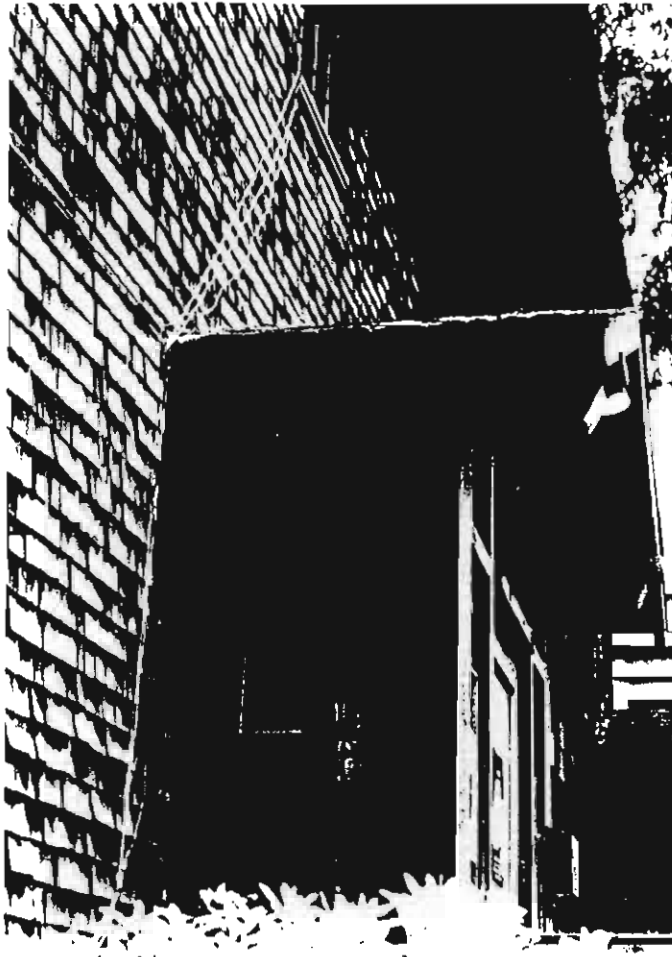
7a. Elevations:
Mossy roof edge at
entrance portico,
shingle conditions.

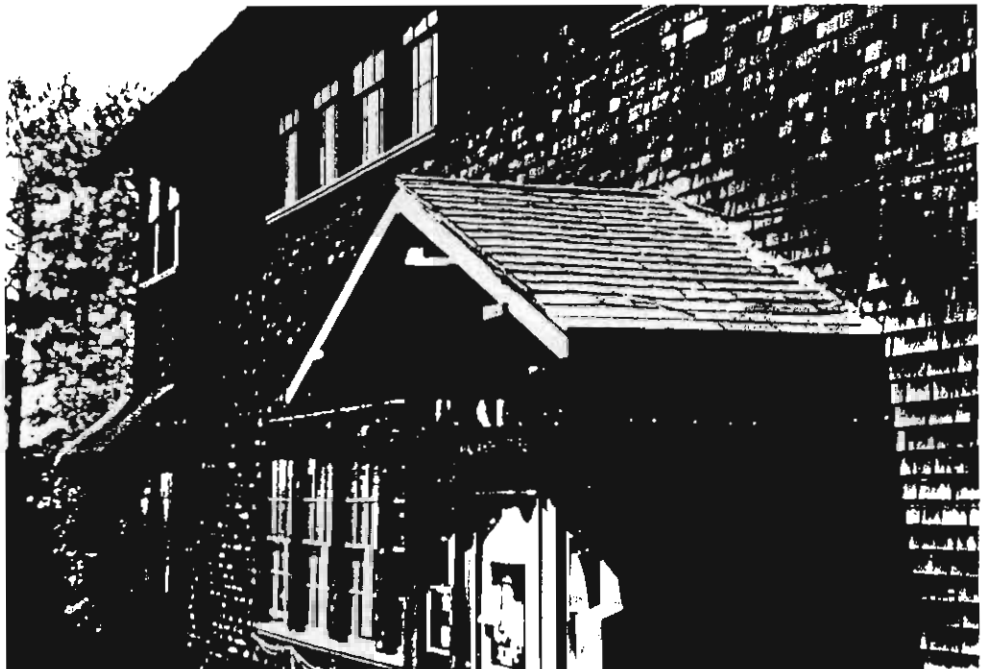
7b. Elevations:
Entrance portico.

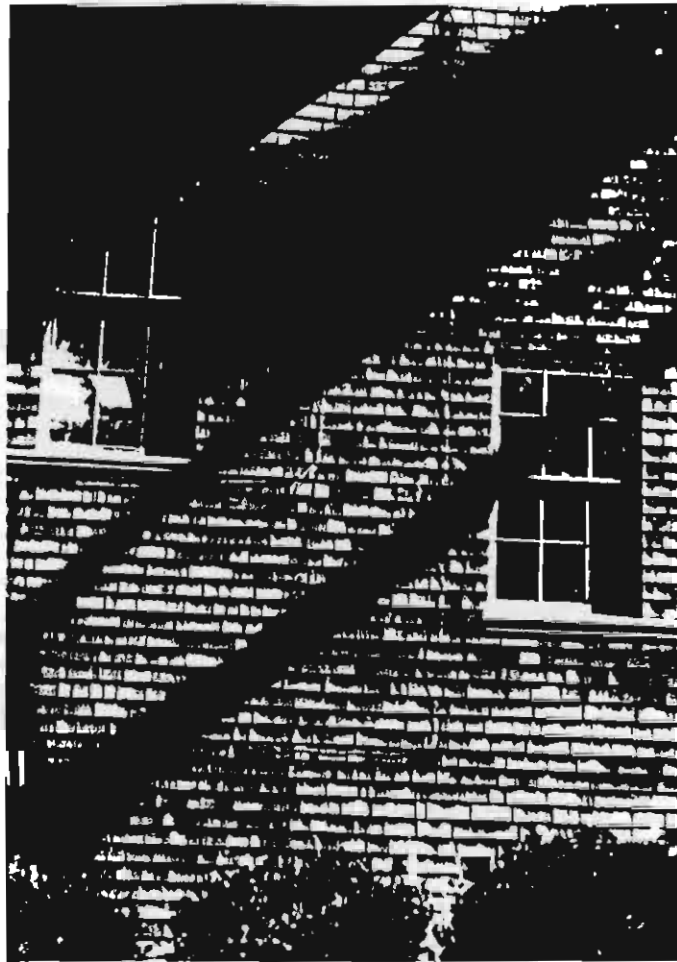
6a. Structural conditions:
Bulge on south side.

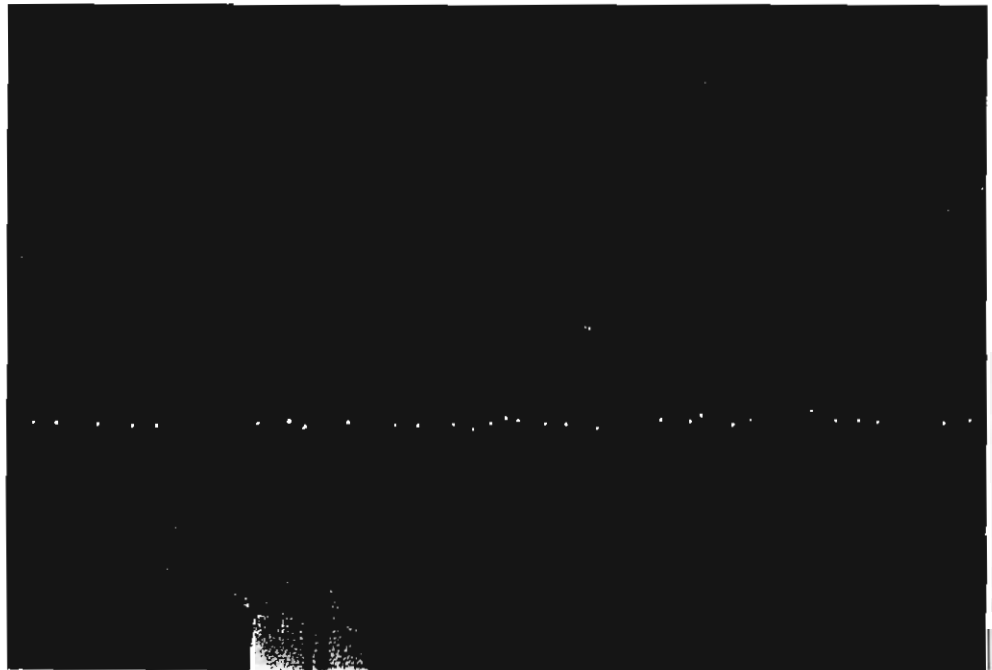
6b. Structural conditions:
Post and beam connection.

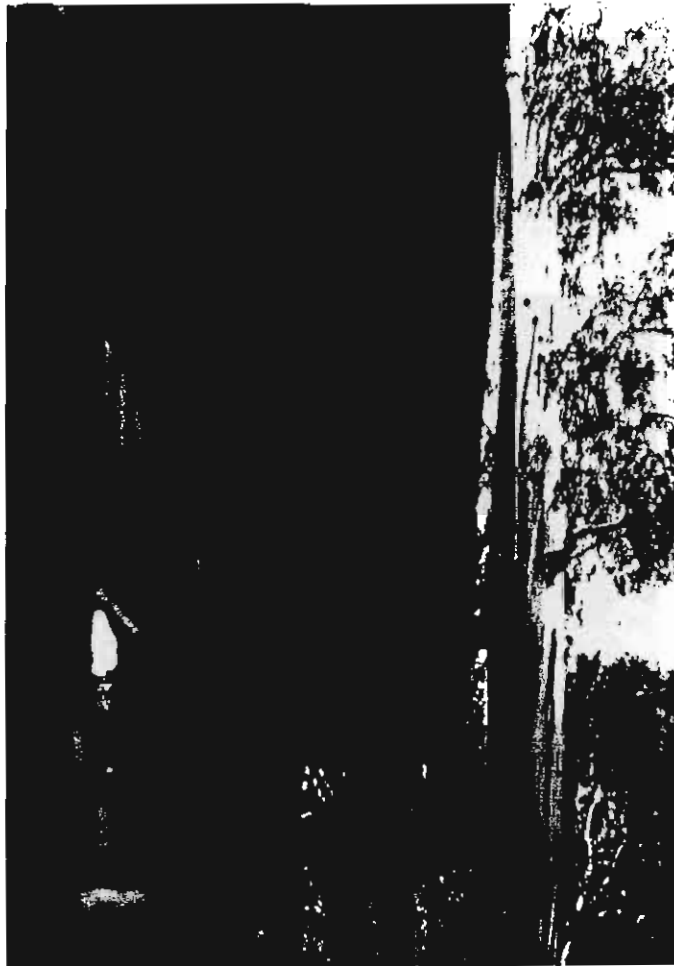
5a. Roof conditions:
End of beam at
west side showing
water stain.

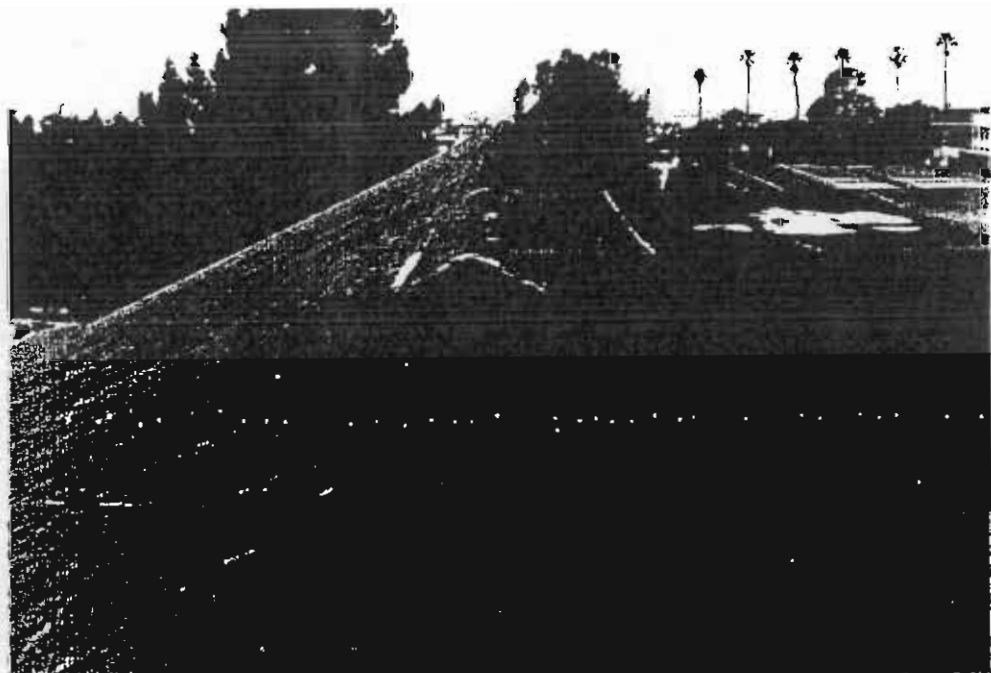
5b. Roof conditions:
Ridge of lower
roof portion with
cupola roof.

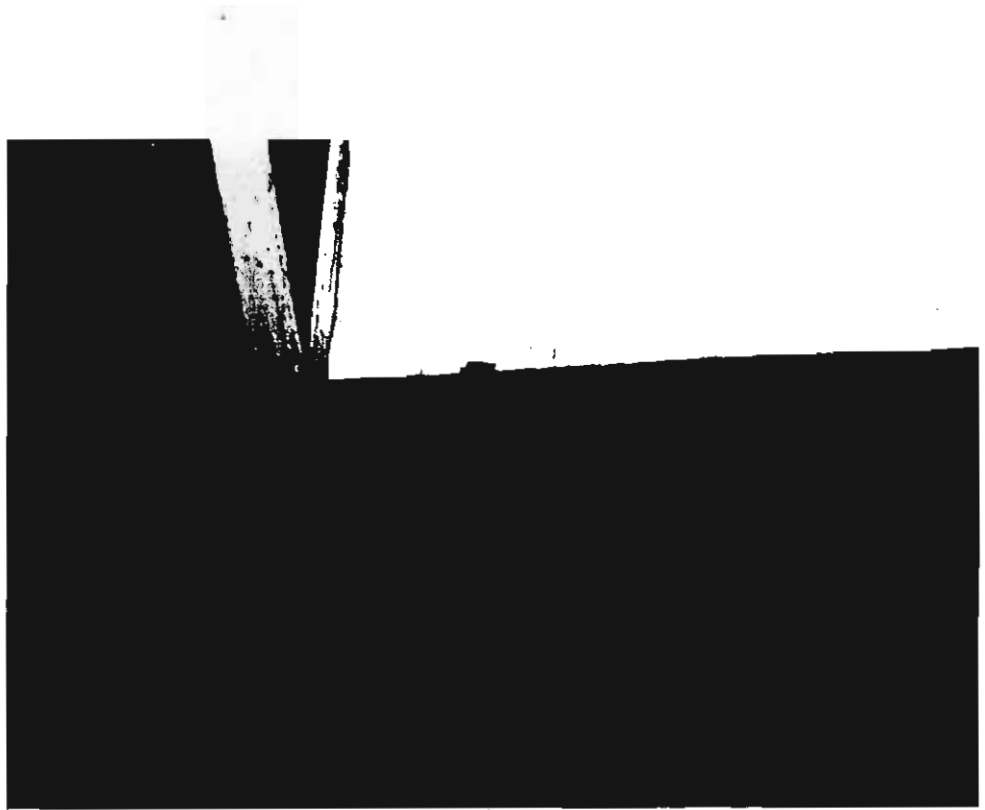
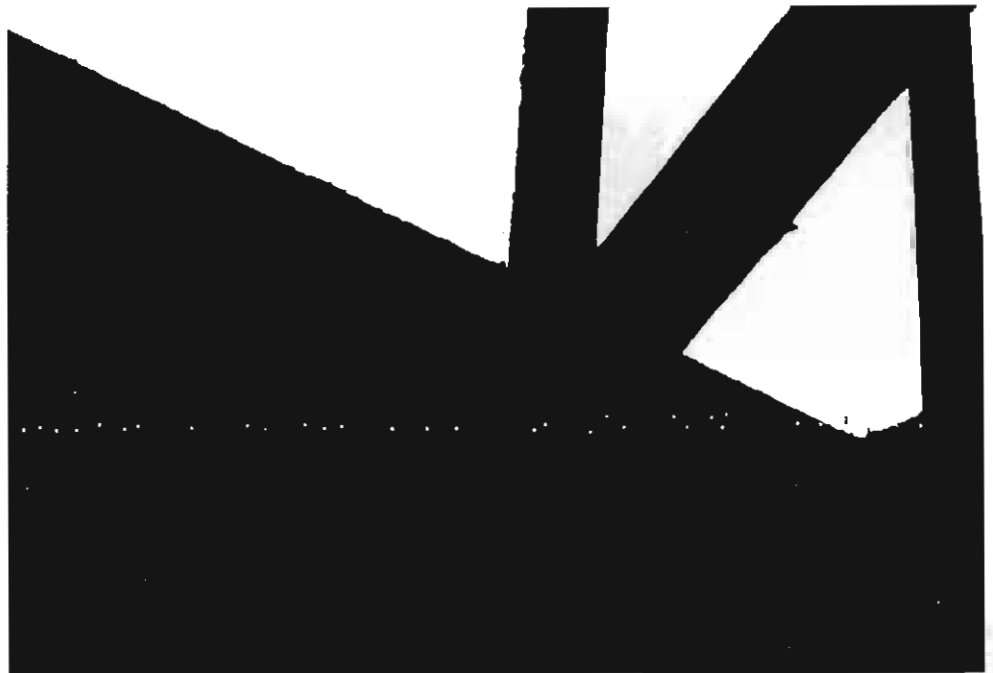
4c+d. Water stains at cupola:
Wall plate, rafters
and cupola lights.

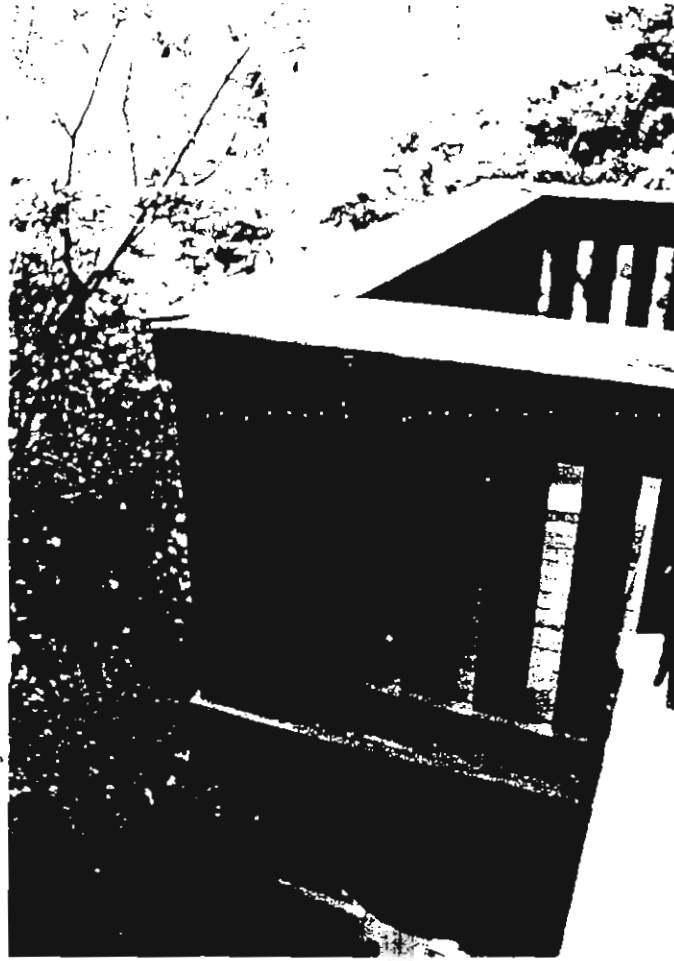
4. Wood in porch has been damaged by fungus (note unfinished floor repair). Replace damaged members and paint to preserve.

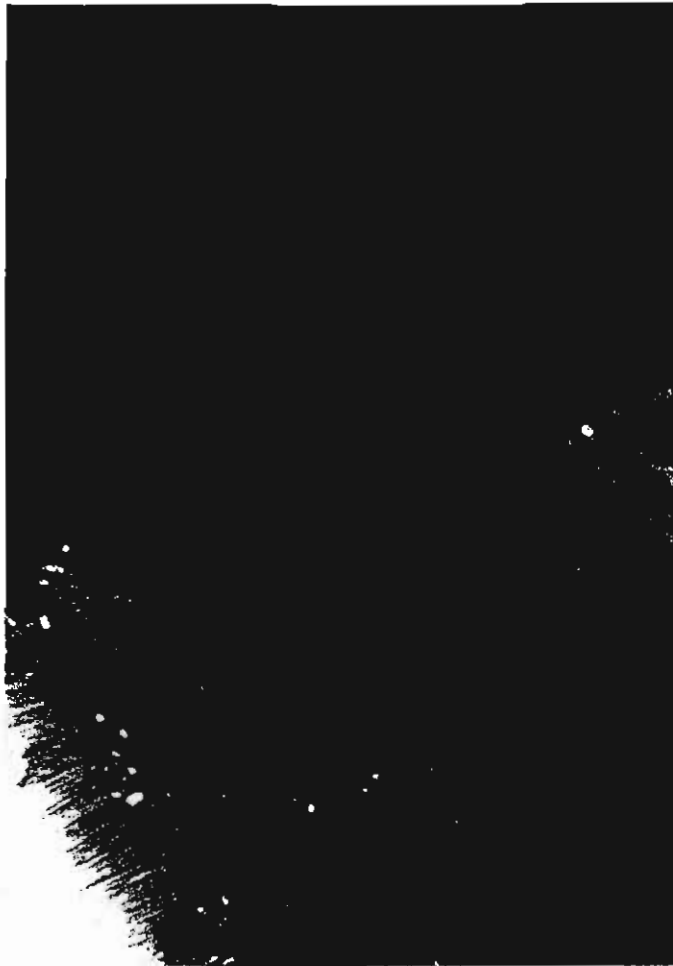
3b. Balcony conditions:
Rotted balcony
railing.
