UNIVERSITY OF CALIFORNIA
BERKELEY

HISTORIC STRUCTURE REPORT

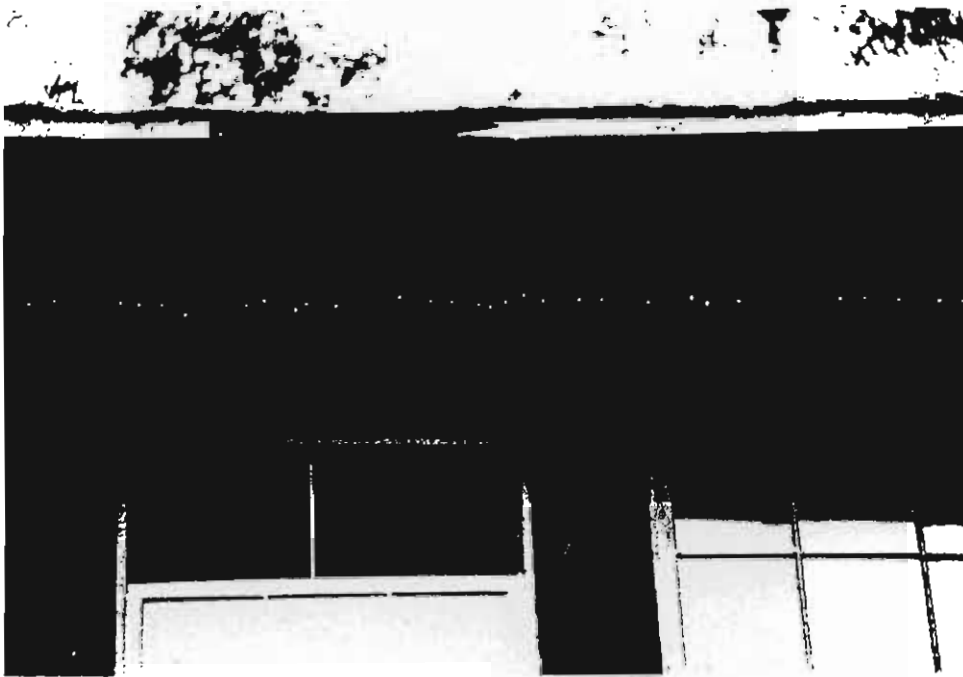
1. Damaged (rotted) facing board under roof indicates that the roof should be inspected by a roofing contractor.

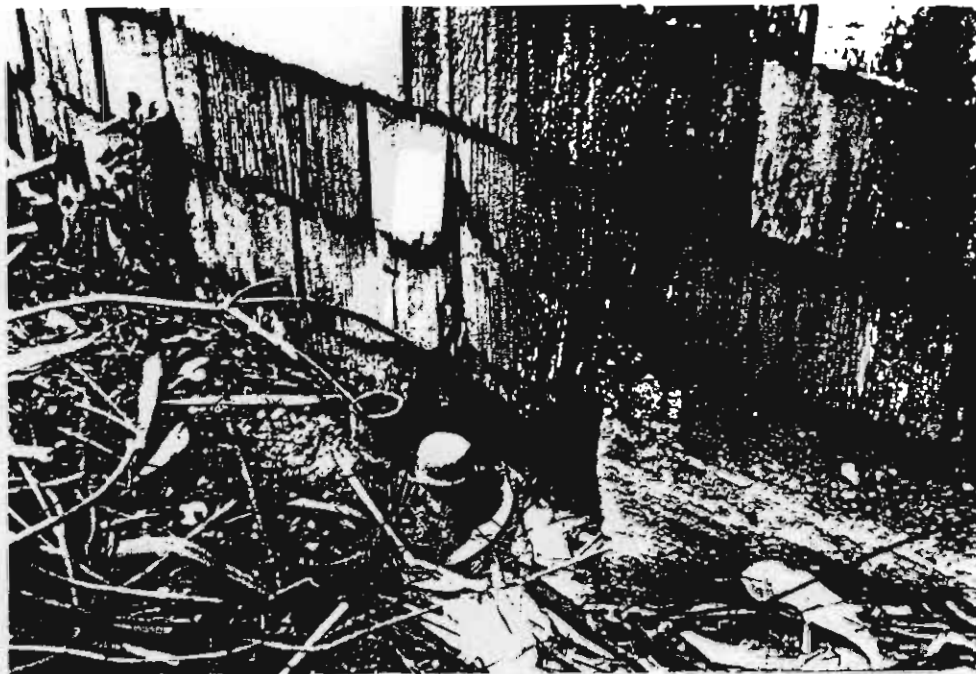
1b. Sill at grade conditions:
Black top at sill
near center of
north elevation.

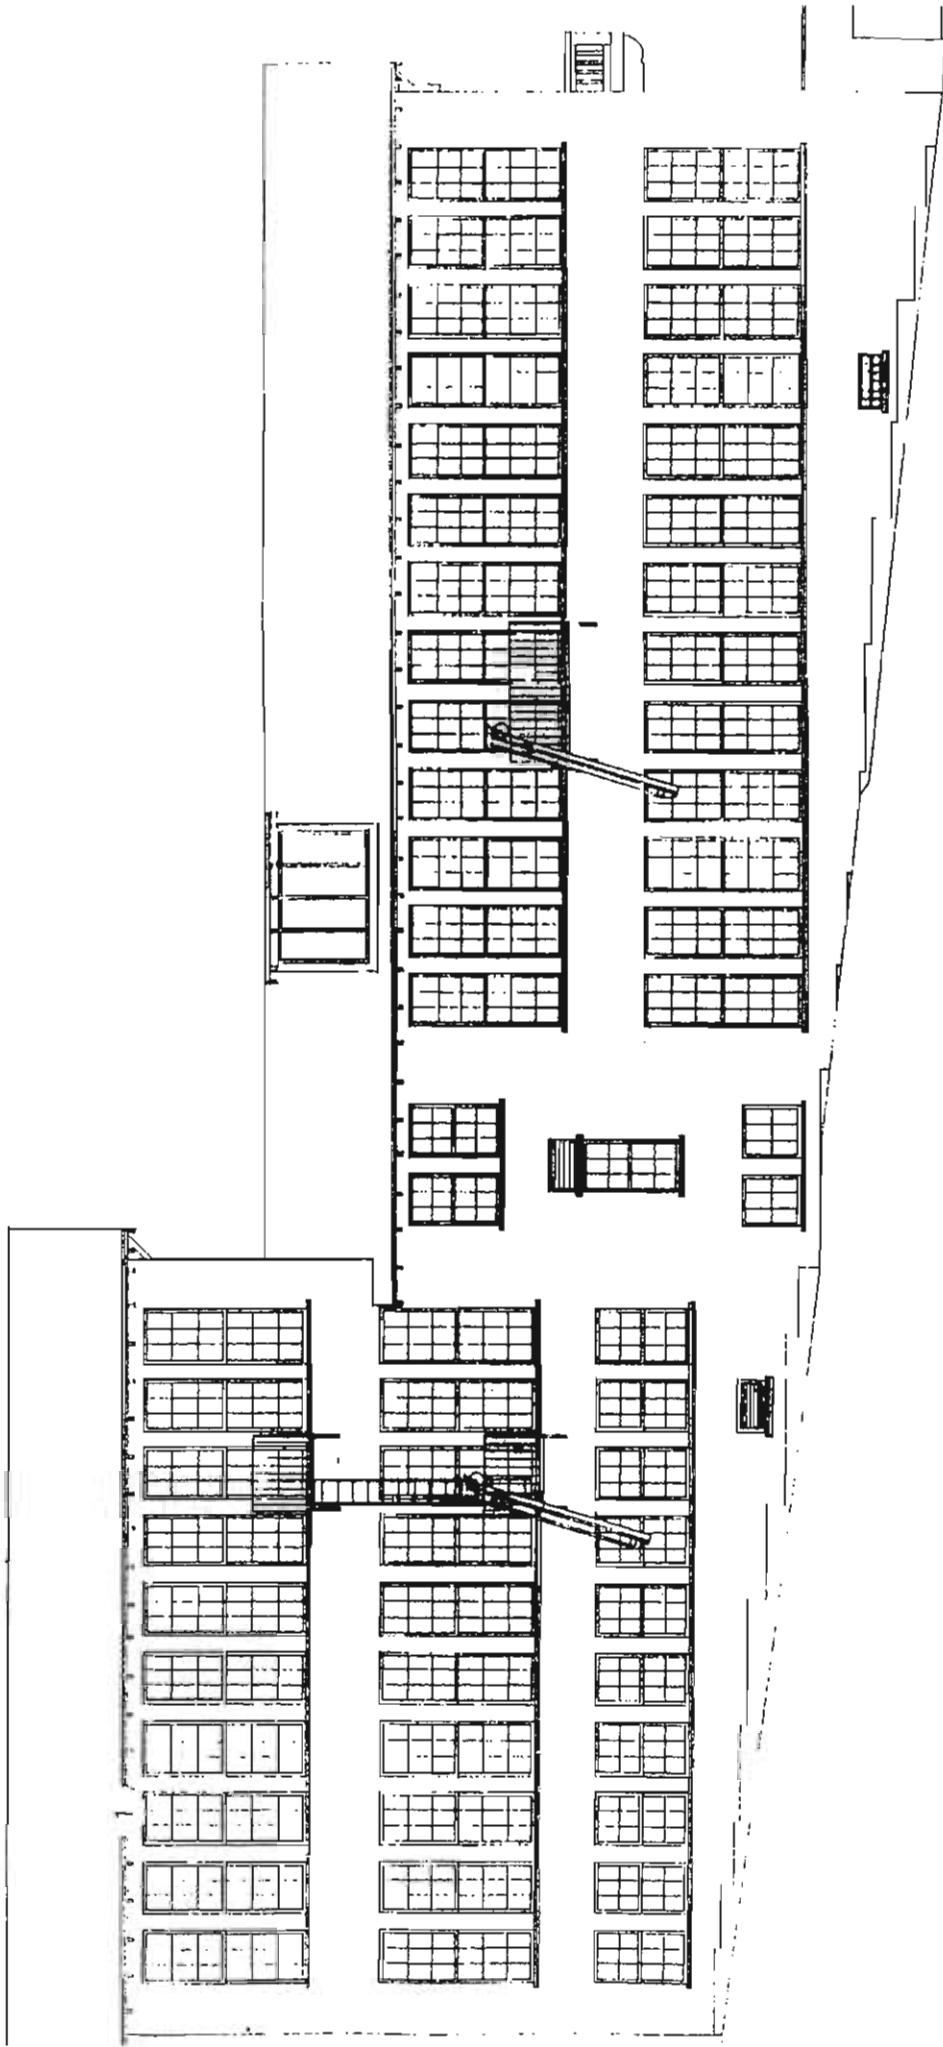
UNIVERSITY OF CALIFORNIA AT BERKELEY
 NAVAL ARCHITECTURE BUILDING
 STUDY AND REPORT

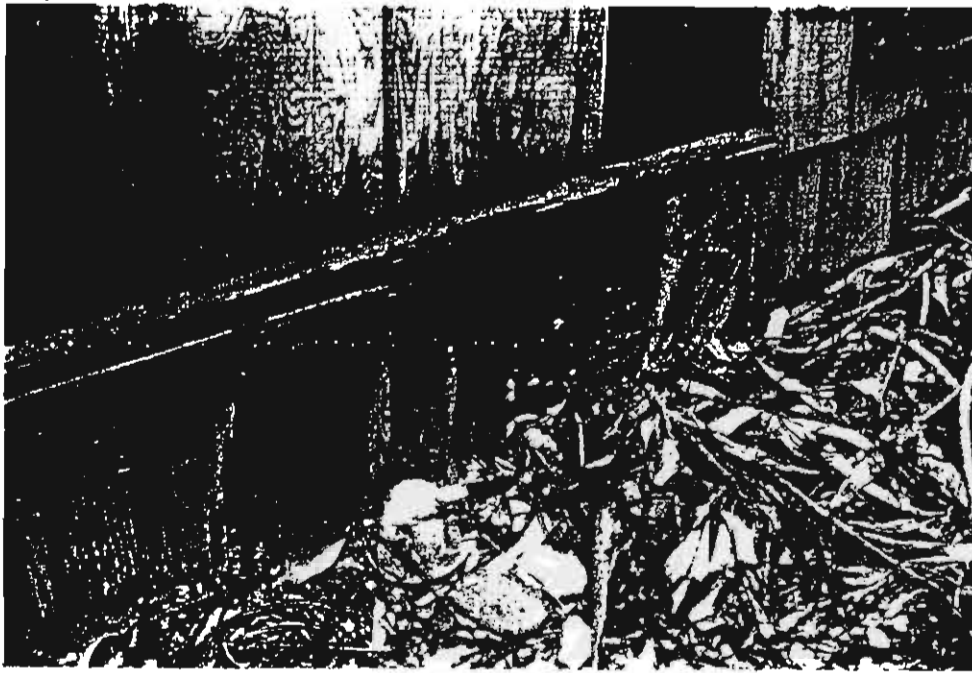
2. Damaged wood behind the shingles. See 1 above.

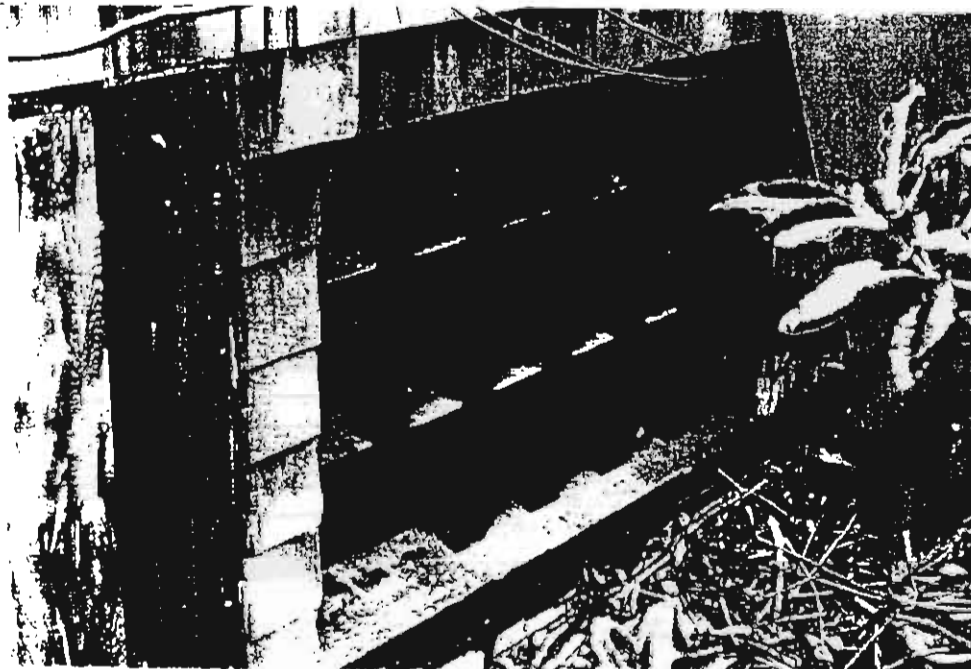
3. Unscreened section of vent: permits access for rodents, skunks, feral cats to the subarea. Screen with 1/4" hardware cloth.

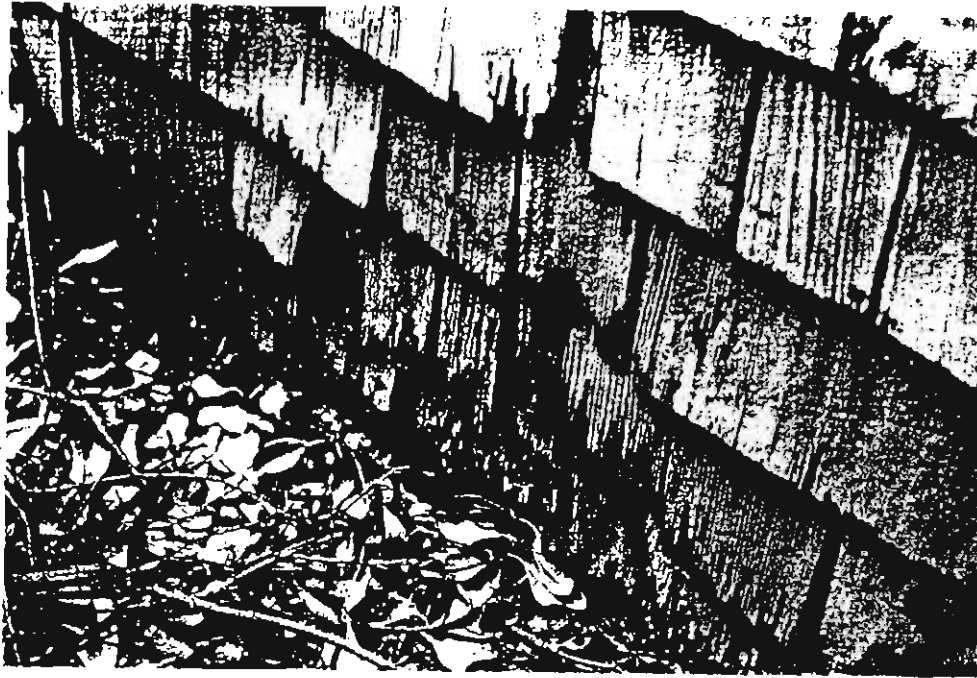
1a. Damaged shingles. Indadequate ground to wood clearance and water draining into the building have created extensive fungus damage at the base of the south facing outside wall.

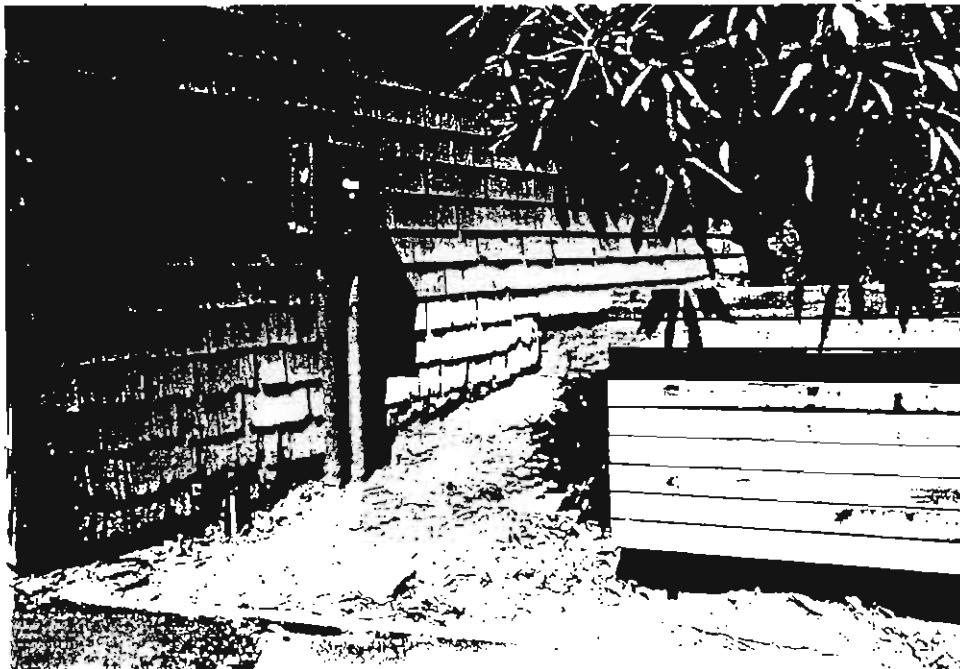
1b Damaged shingles Refer to above

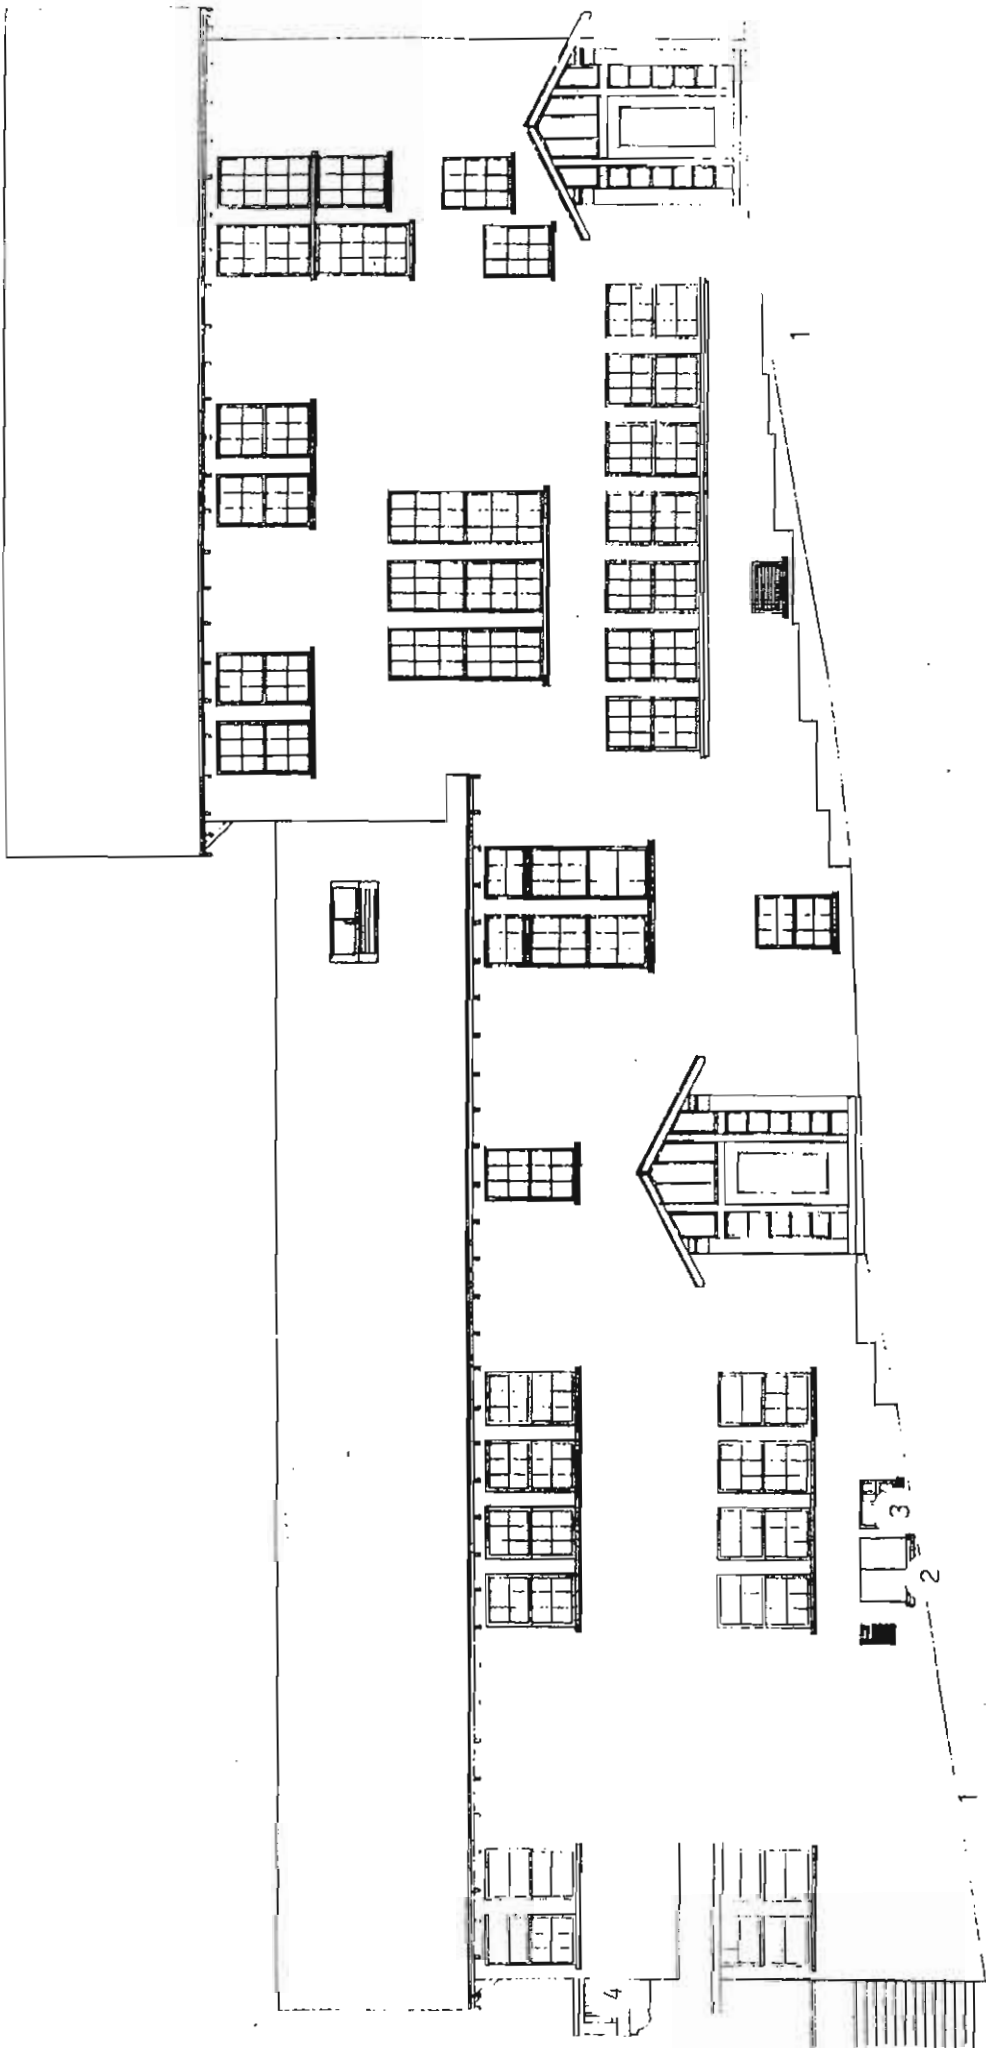
UNIVERSITY OF CALIFORNIA AT BERKELEY
 NAVAL ARCHITECTURE BUILDING
 STUDY AND REPORT

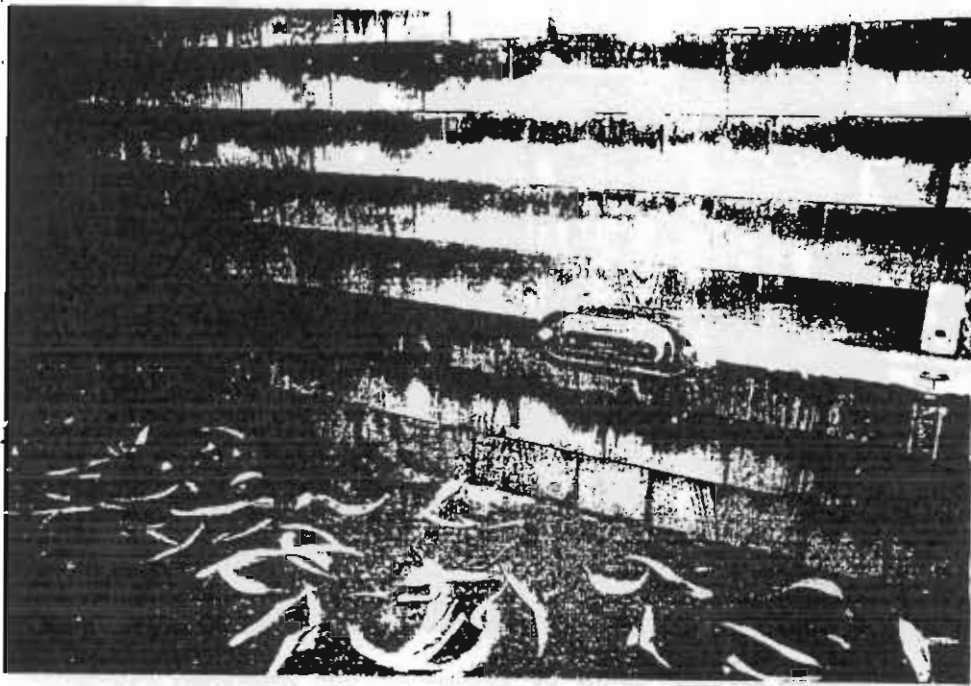
13. Asphalt laid over base of shingles providing continuous earth to ground contact on east wall and on a section of the north wall. Raise the foundation, or excavate the ground to eliminate the earth to wood contacts.

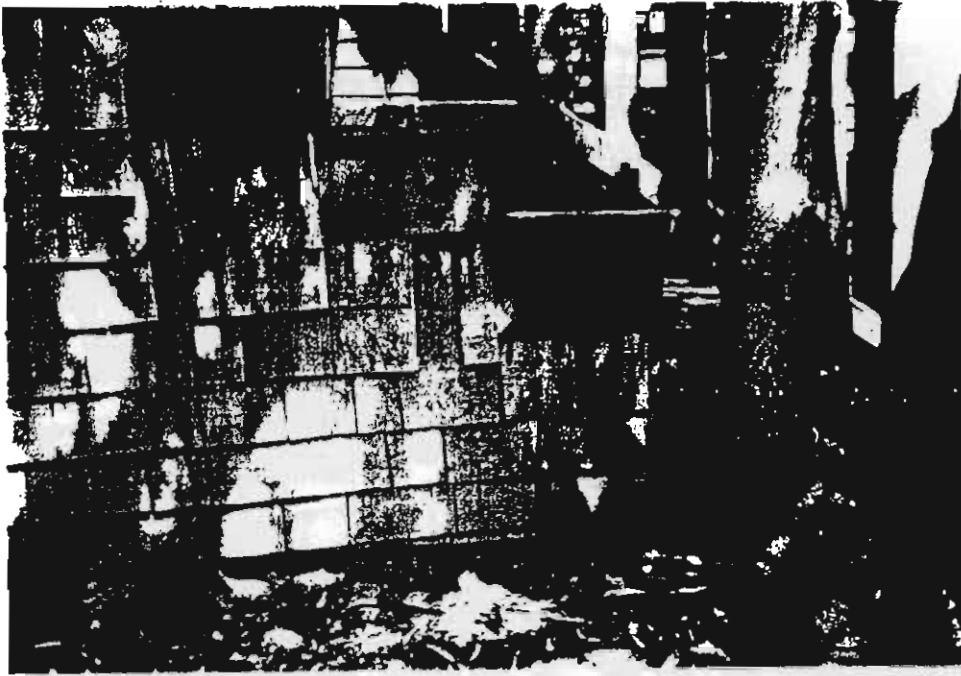
11. Outside wall of porch showing skunk excavation through weakened foundation. Replace foundation to code.

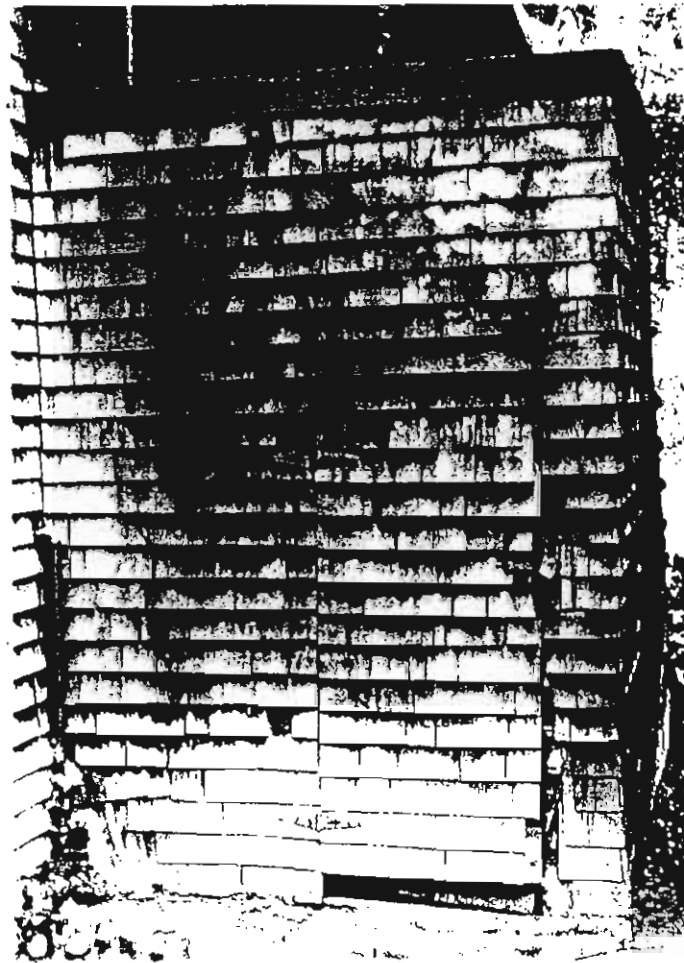
12. Door to area under porch has excessive clearance and needs to be reconstructed to exclude rodents. Clearance should be less than 1/4" to exclude mice.

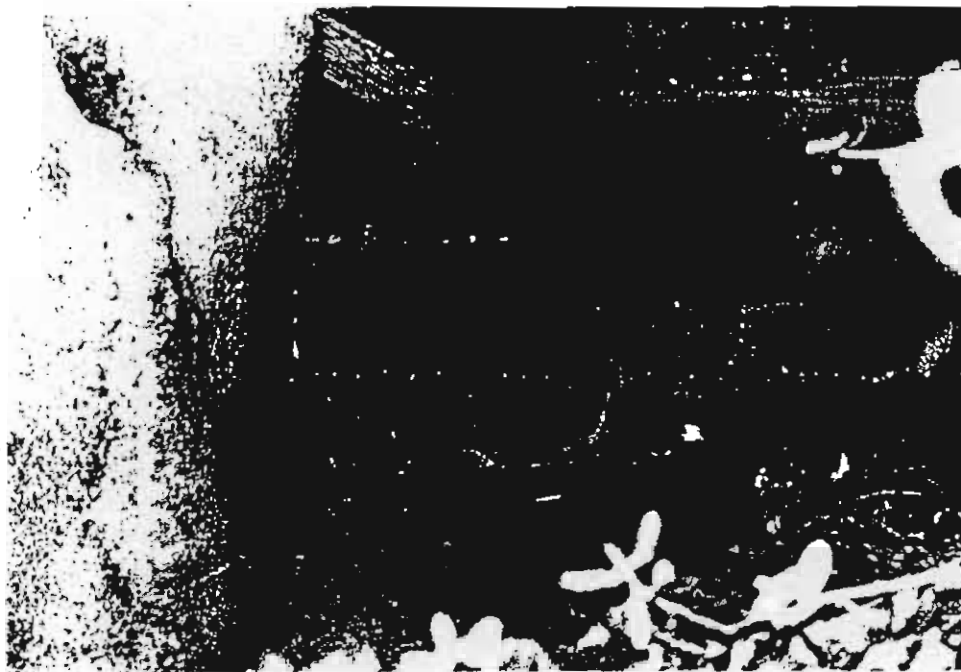
9. Base of porch showing extensive fungal decay because of wood to earth contact. Reconstruct base of porch to eliminate earth to ground contact and provide a minimum of 6" clearance.

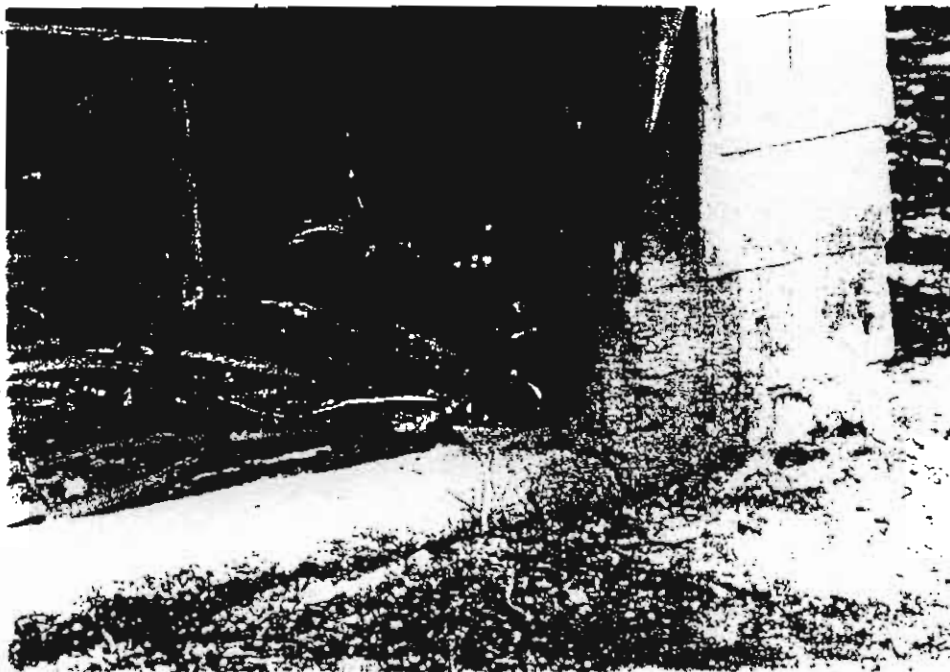
10. Inside wall of porch showing earth to wood contact. Excavate or raise foundation to provide 6" clearance. The foundation is in poor condition (see 11) and should be replaced.

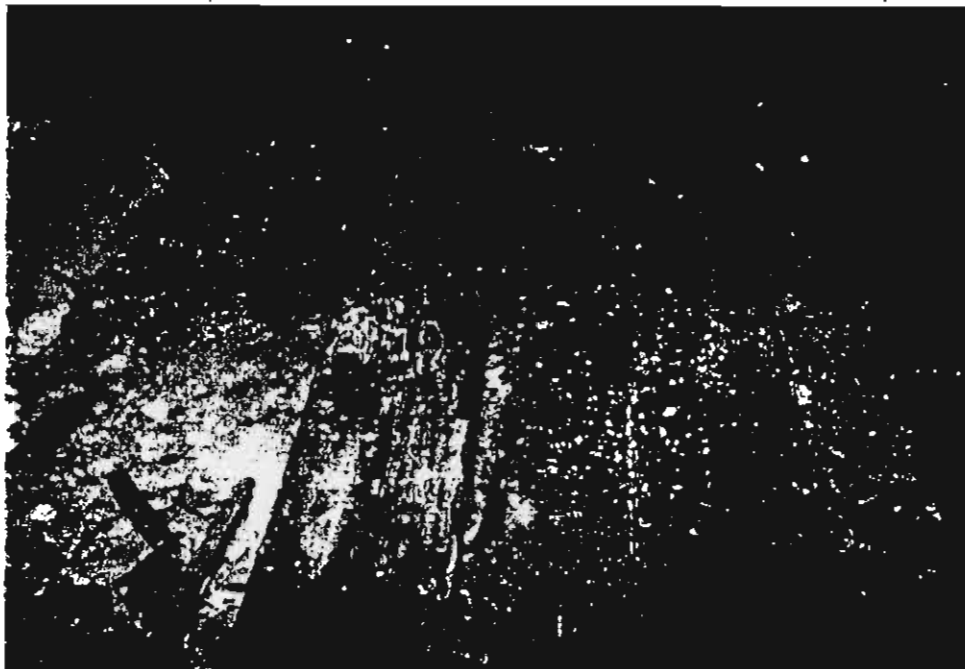
7. Subterranean termite (*Reticulitermes hesperis*) damage in boards in subarea. Infestation is not active. Remove and dispose of boards.

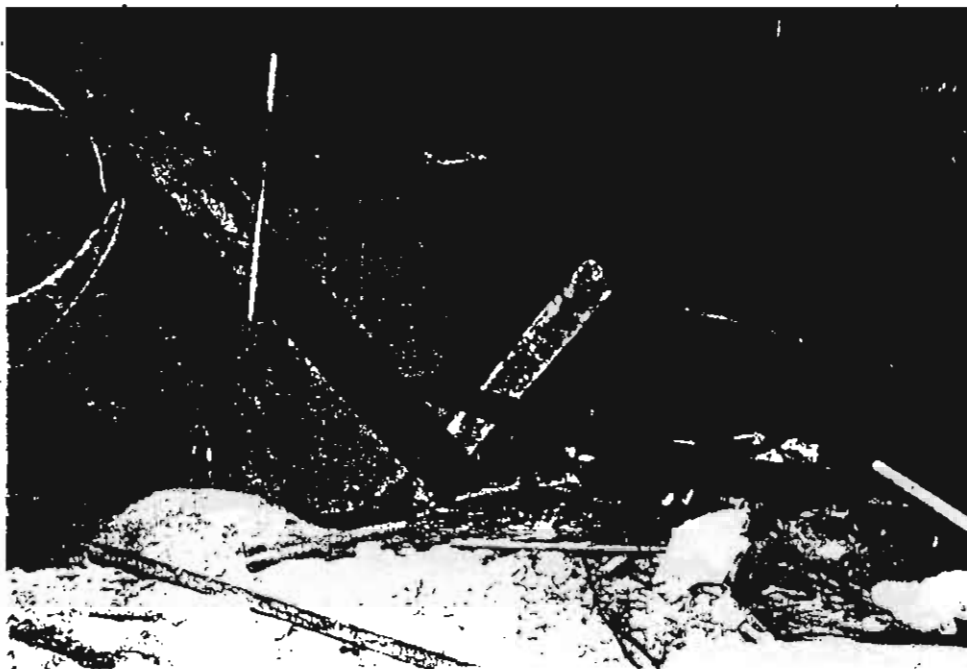
8. Scrap wood in the subarea. Remove and dispose of boards.

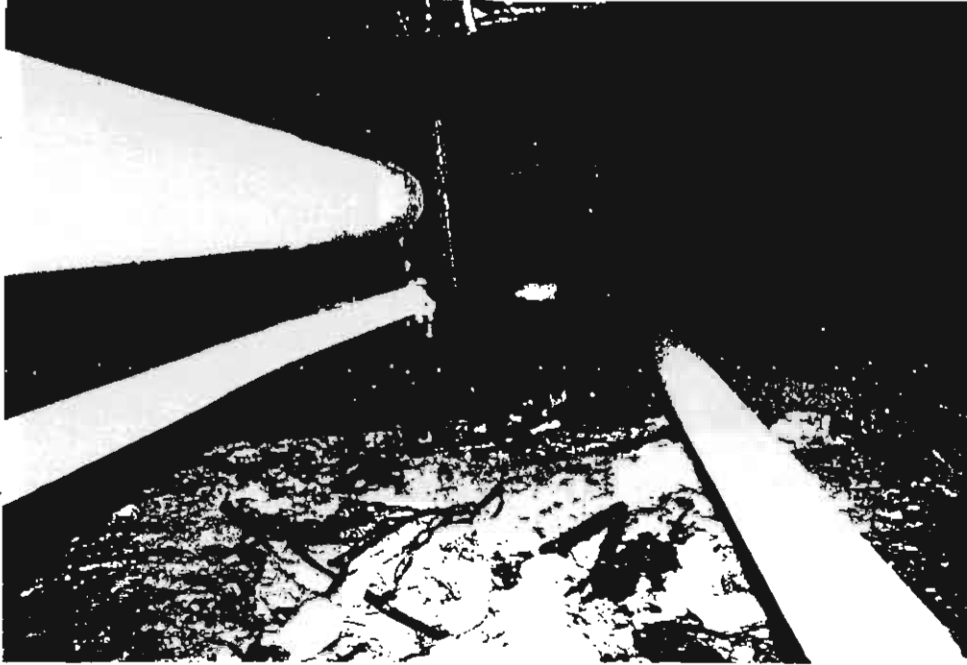
5. Foundation forms left in place. Remove.

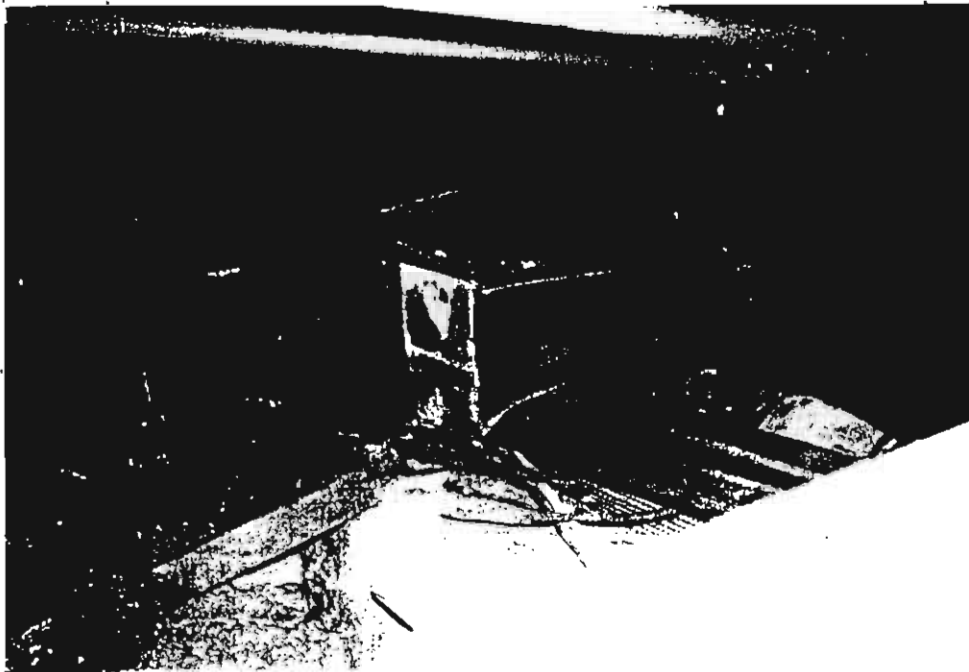
6. Scrap wood and cardboard stored in subarea. Remove.

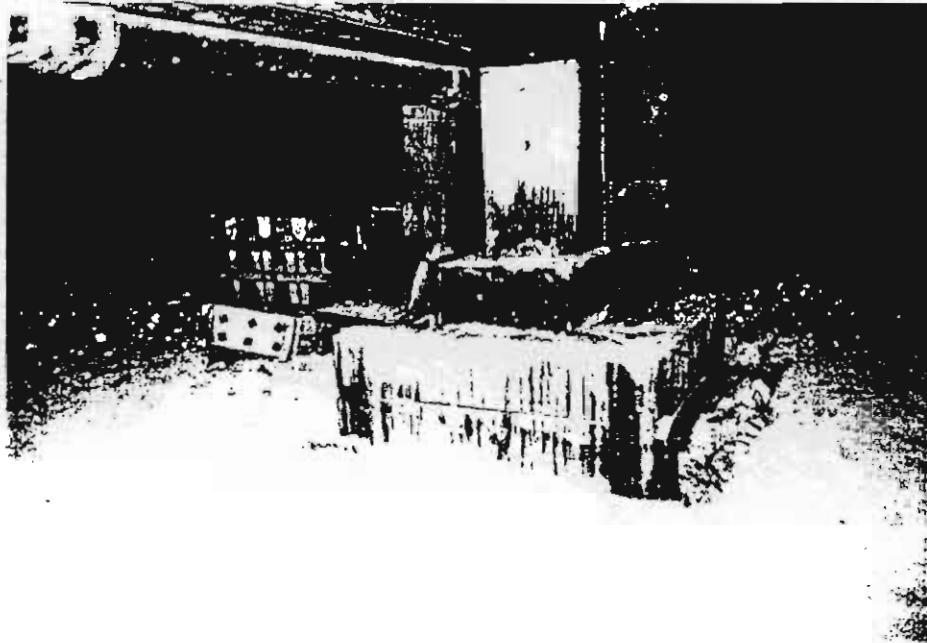
3. Wood forms around base of piers (6 ea. in upper (east) and lower (west) subareas). Recommend removing the forms.

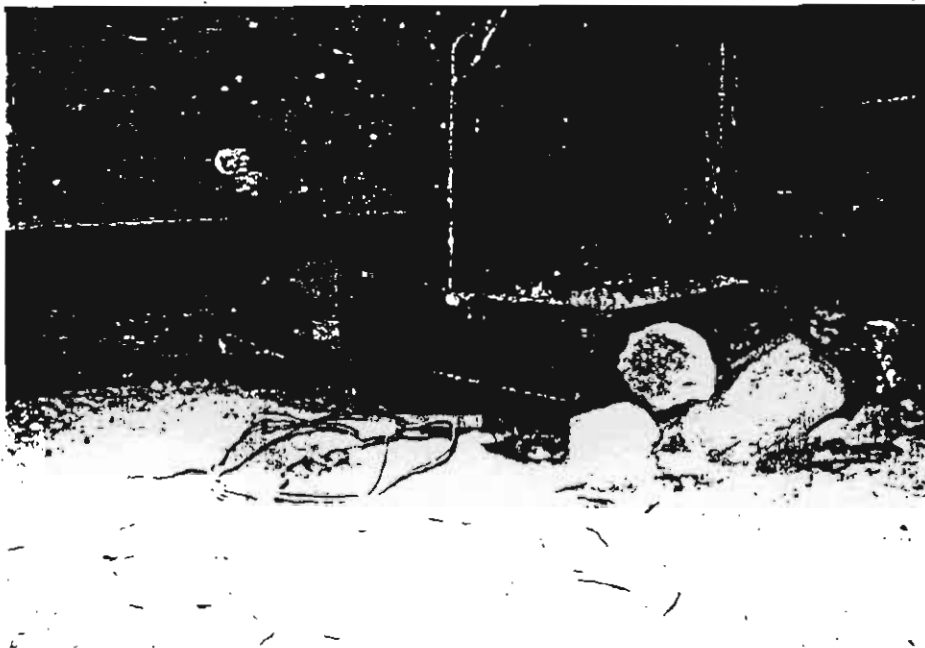
4. Forms penetrating the foundation and providing continuous contact from the earth to the sill. Repair to bring to code, or provide chemical barrier.

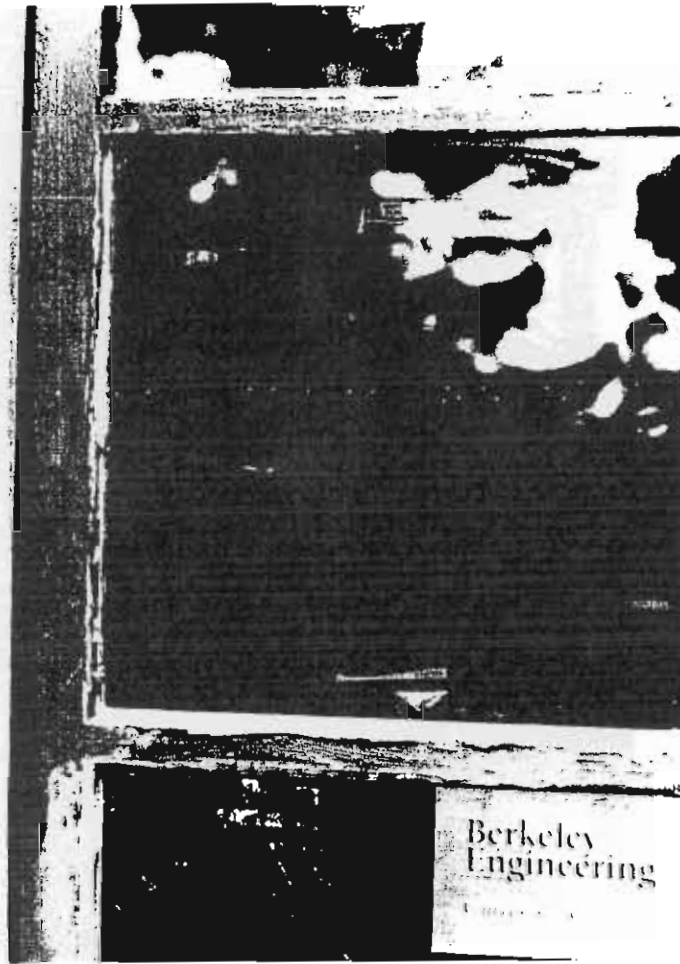
2c. Glazing and sash conditions: Bottom light of entrance portico.

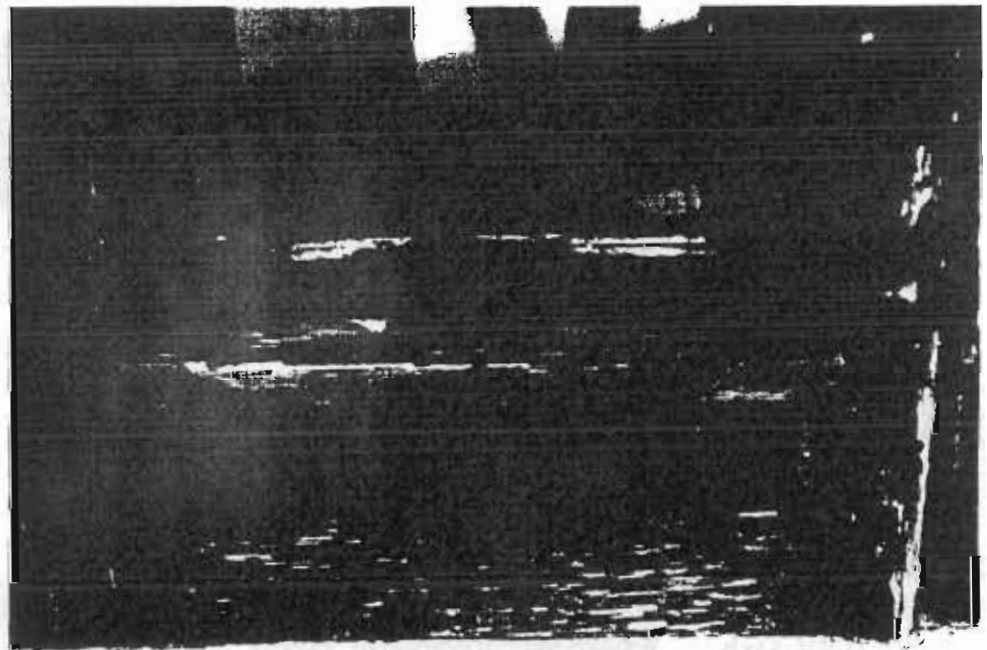
2d. Glazing and sash conditions:
Broken window pane, rotted sill at
3rd floor classroom.

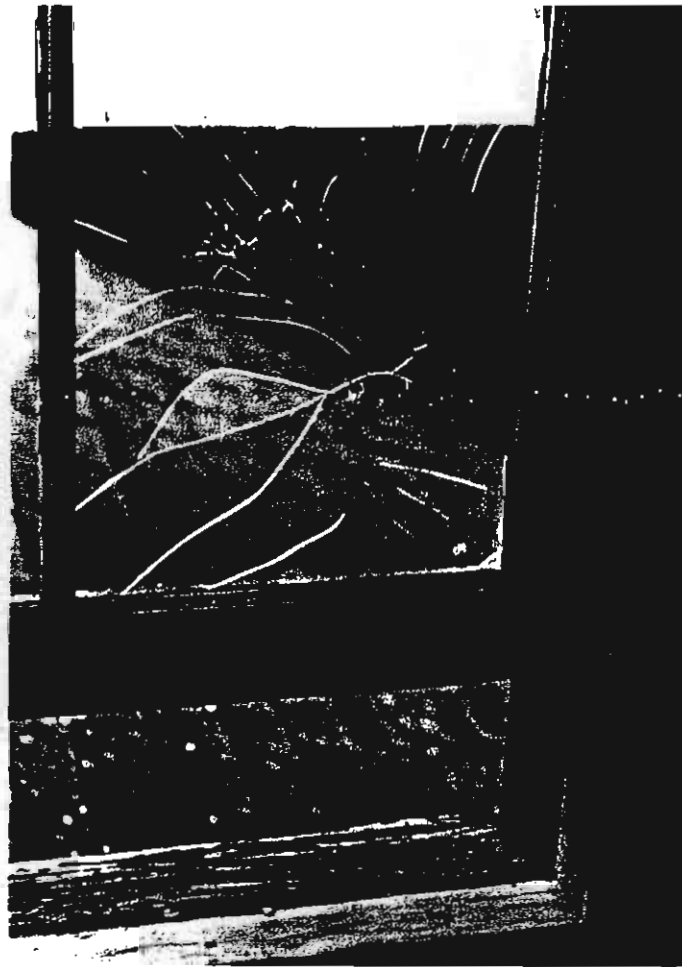
2e. Glazing and sash conditions:
Balcony door sash.

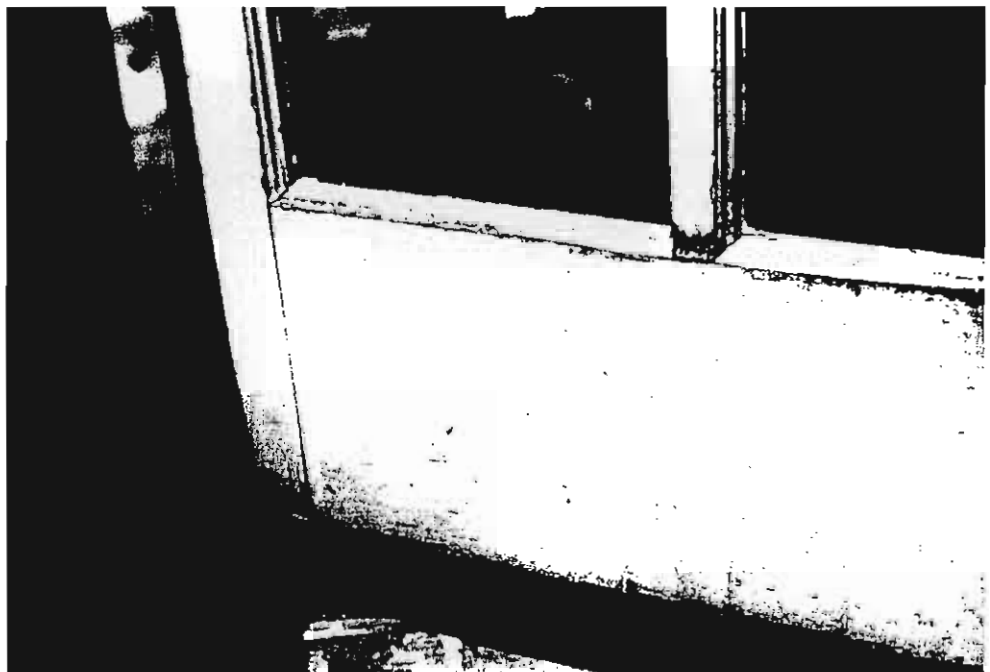
1c. Sill at grade conditions:
Lacking stem wall
on side of
entrance portico.

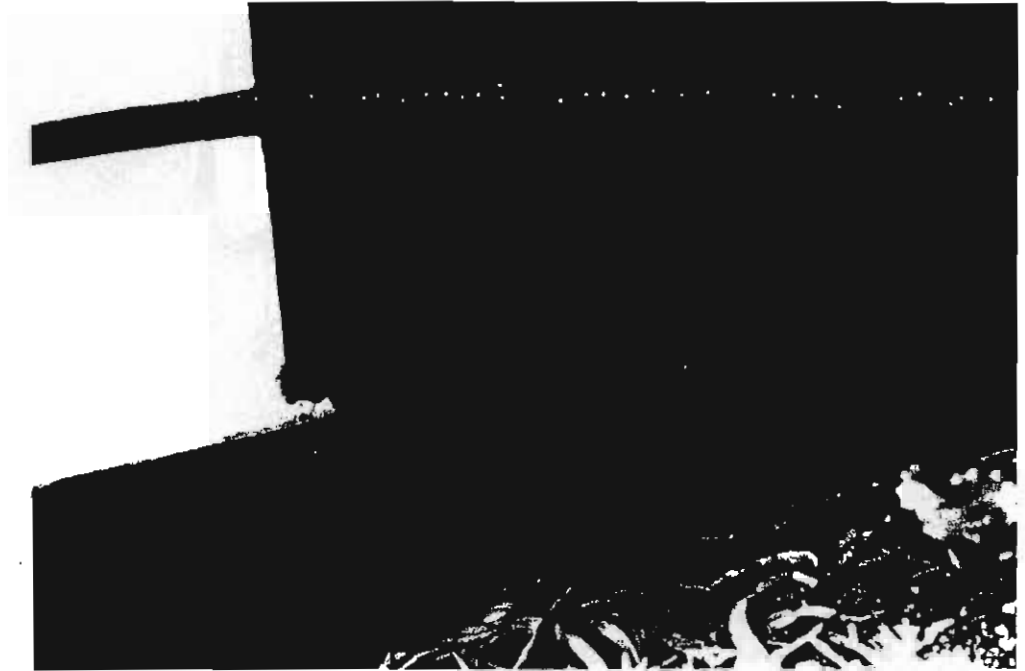
2a. Glazing and
sash conditions:
Typical unpainted
sash on south side.

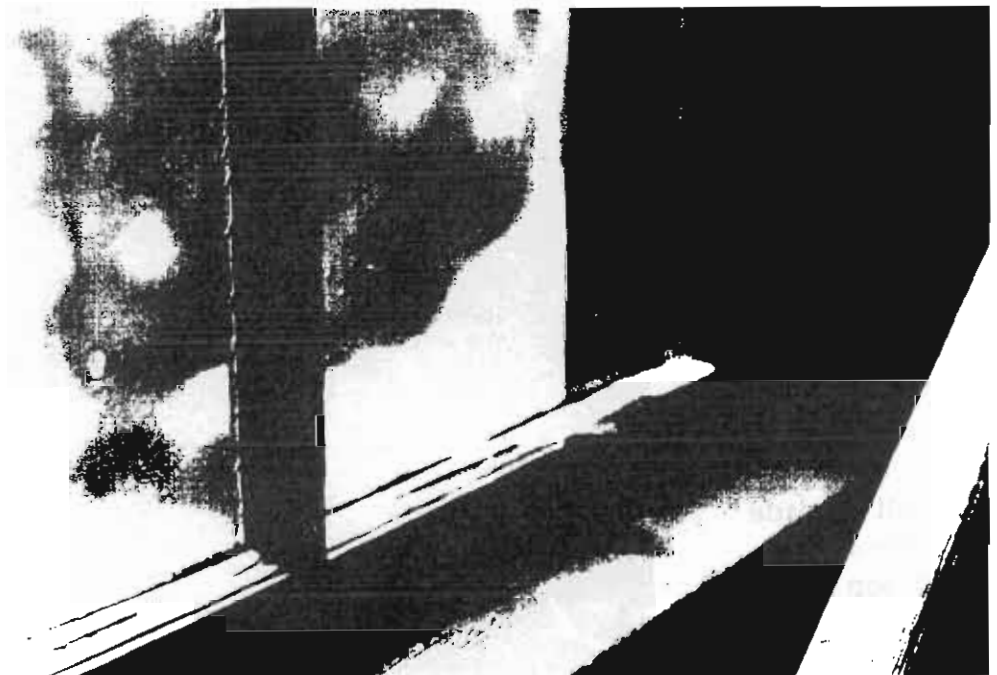
1a. Sill at grade conditions:
Rotted mud sill at south elevation.

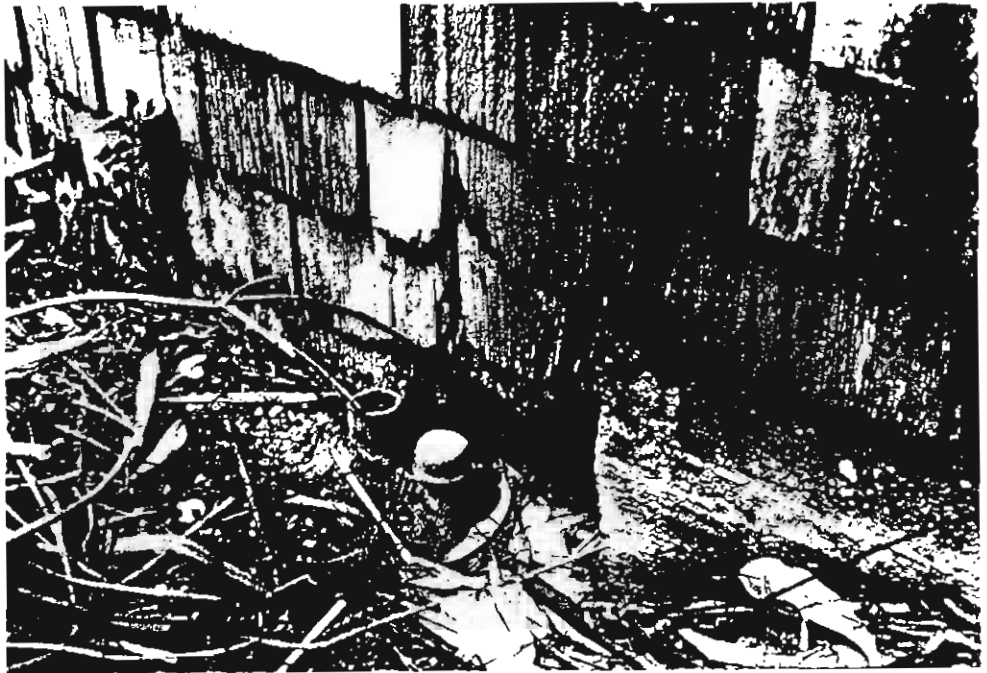
1b. Sill at grade conditions:
Black top at sill near center of north elevation.

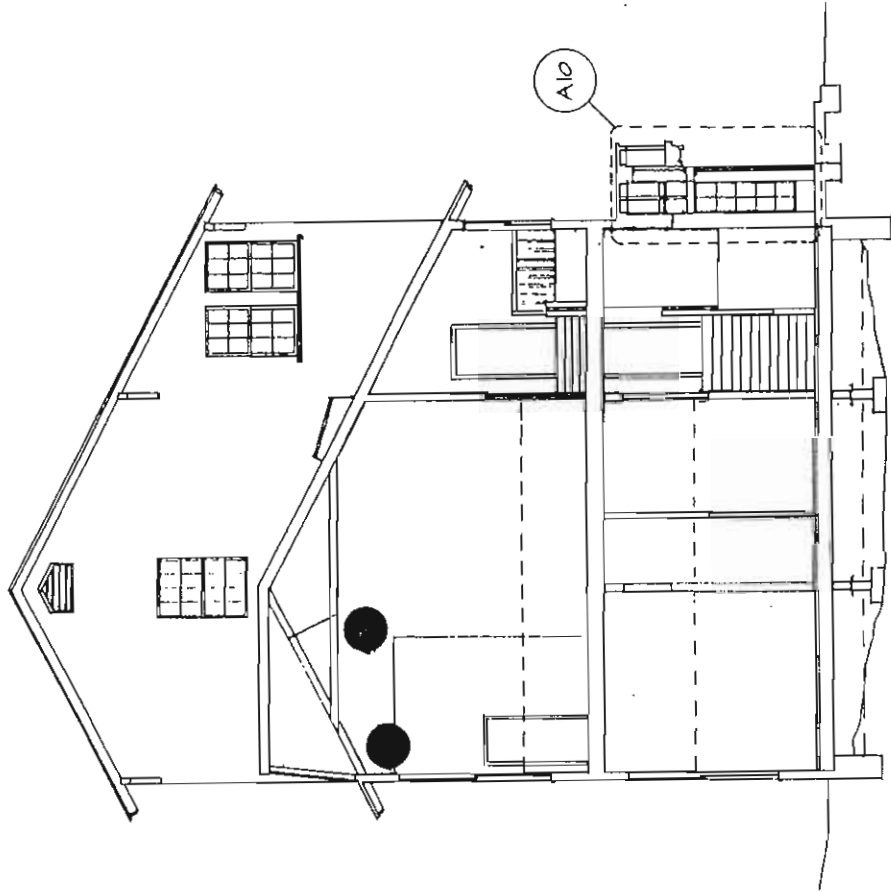
UNIVERSITY OF CALIFORNIA
 AT BERKELEY
 NAVAL ARCHITECTURE
 BUILDING STUDY

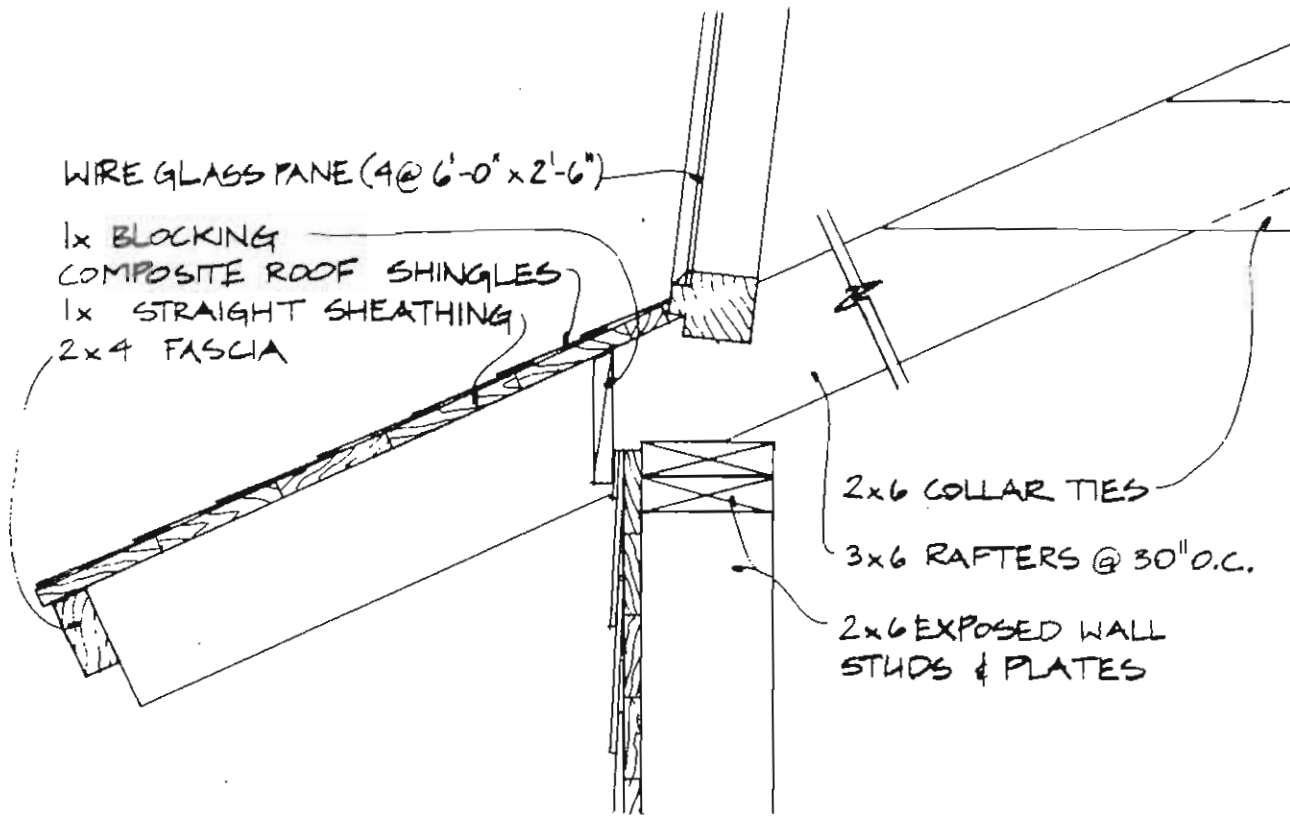
EXISTING DETAIL
AT CUPOLA
